LICENSED
www.magnuminspections.com
Phone: (954) 340-6615

INSURED
ev@magnuminspections.com
Phone: (954) 340-6615

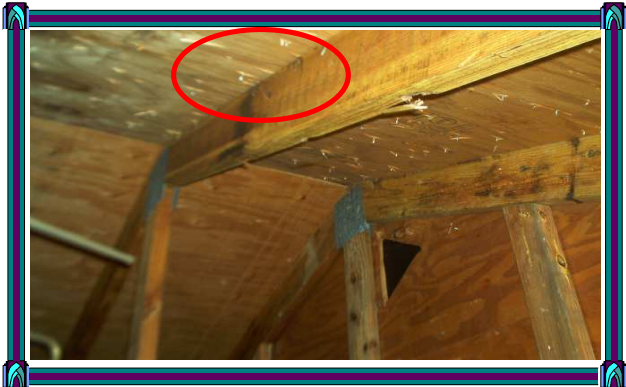
Nails that have missed the trusses. There were a few nails like this throughout the roof.

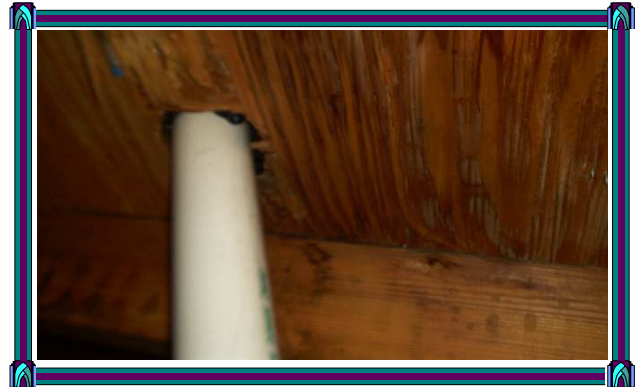
Rotted/damaged decking observed at right side vent stack.

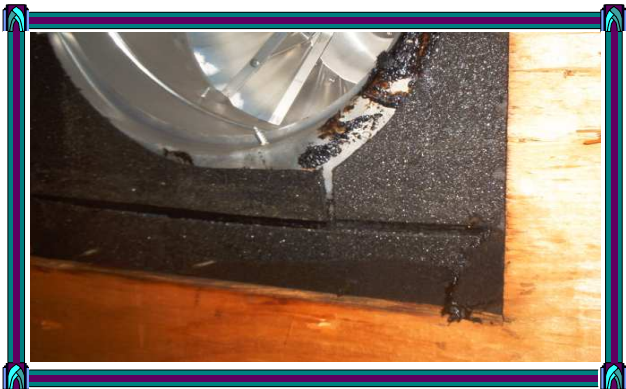
Missing plywood observed at left side turbine fan. There is no wood under the metal lip of this turbine fan base.

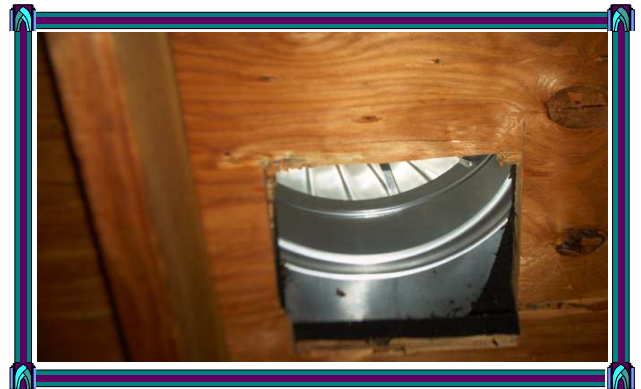
The right side turbine fan is installed in a manner that only allows for a third of the fan to be used.

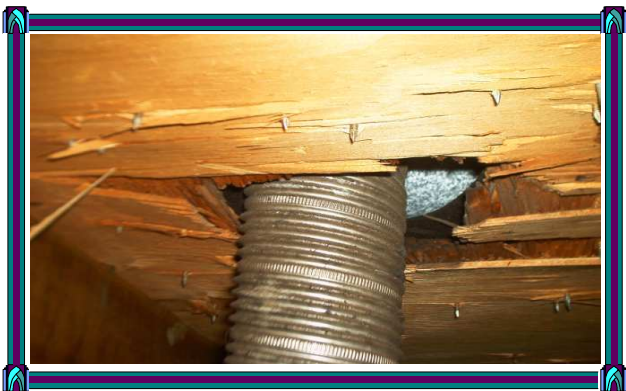
Rotted/damaged decking at dryer vent stack.

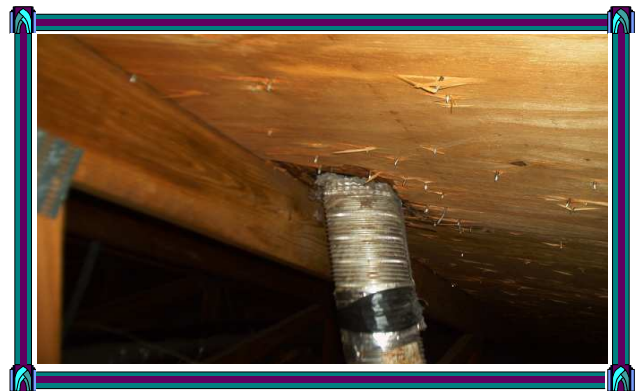
Rotted/damaged wood at bathroom vent fan vent stack.

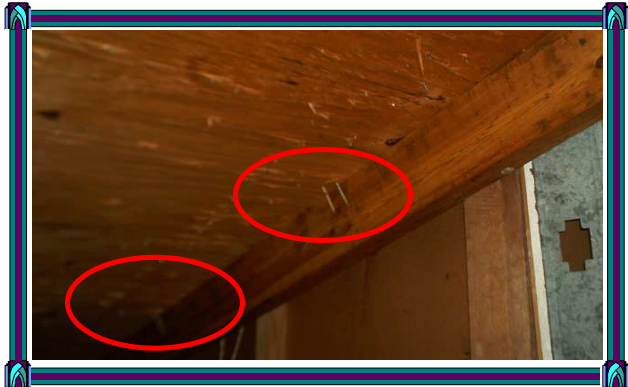
More nails that missed the trusses.

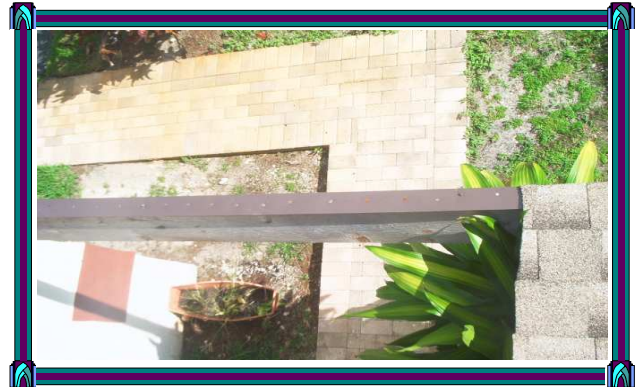
Metal flashing nailed from above at decorative beam. The nails have already started to rust. The beam will rot prematurely.

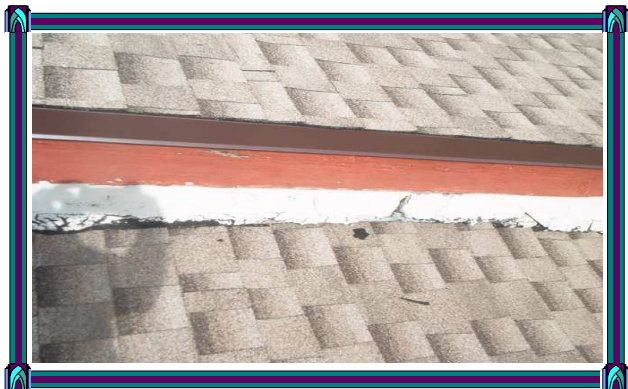
Damaged stucco at roof flashing. The homeowner stated water was entering at this point. Due to the numerous voids, water is most likely entering the structure.

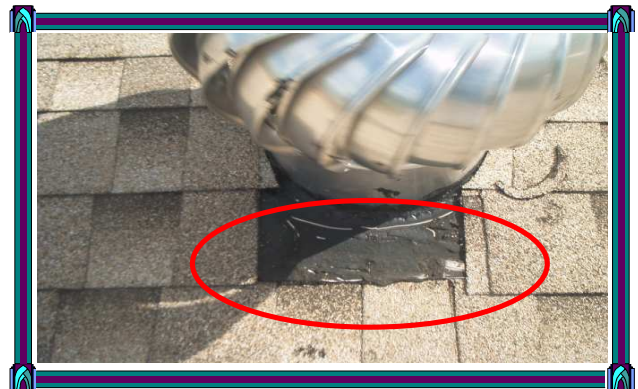
This is the base of the turbine fan. There is no wood under the metal flap.

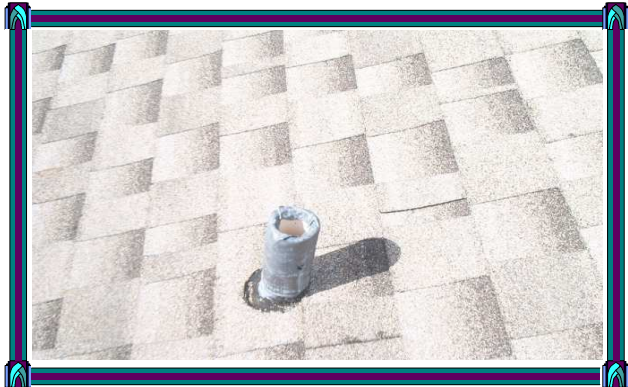
Another vent stack that was not changed.

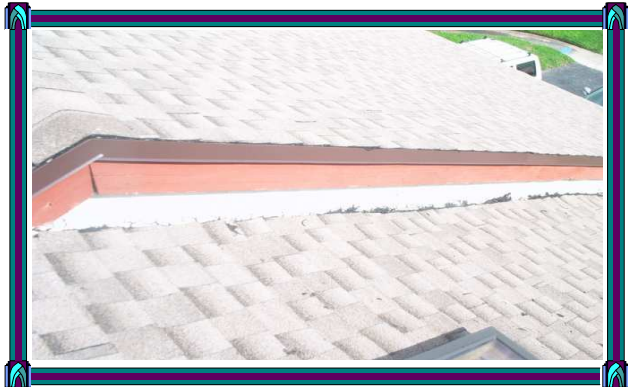
Full view of damaged stucco and exposed wire mesh at living room/garage roof joint.

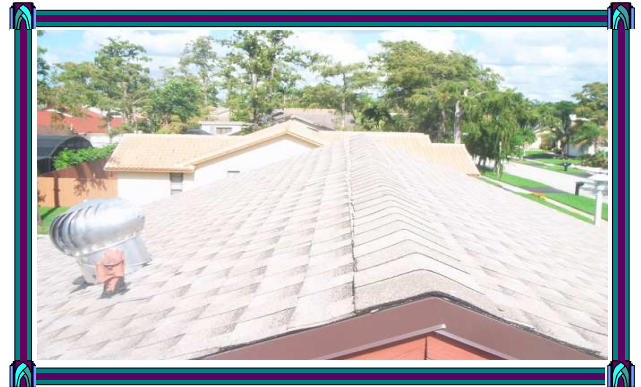
Uneven shingle installation at peak of roof.

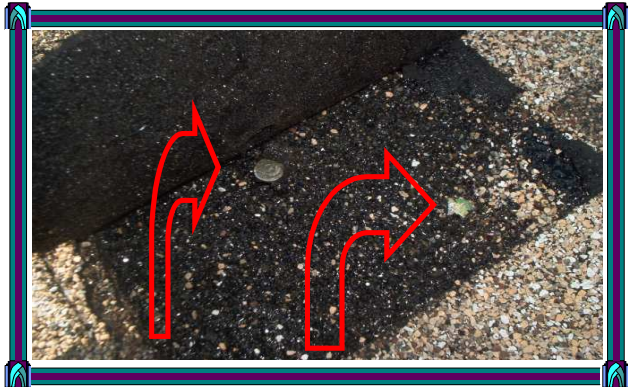
Under-driven nail and over-driven nail in field shingles.

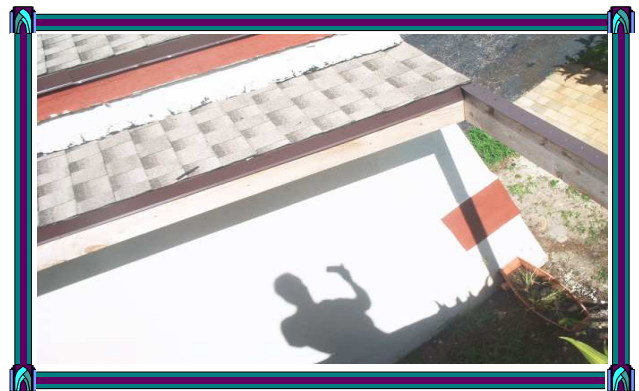
More damaged stucco at living room/garage roof joint.

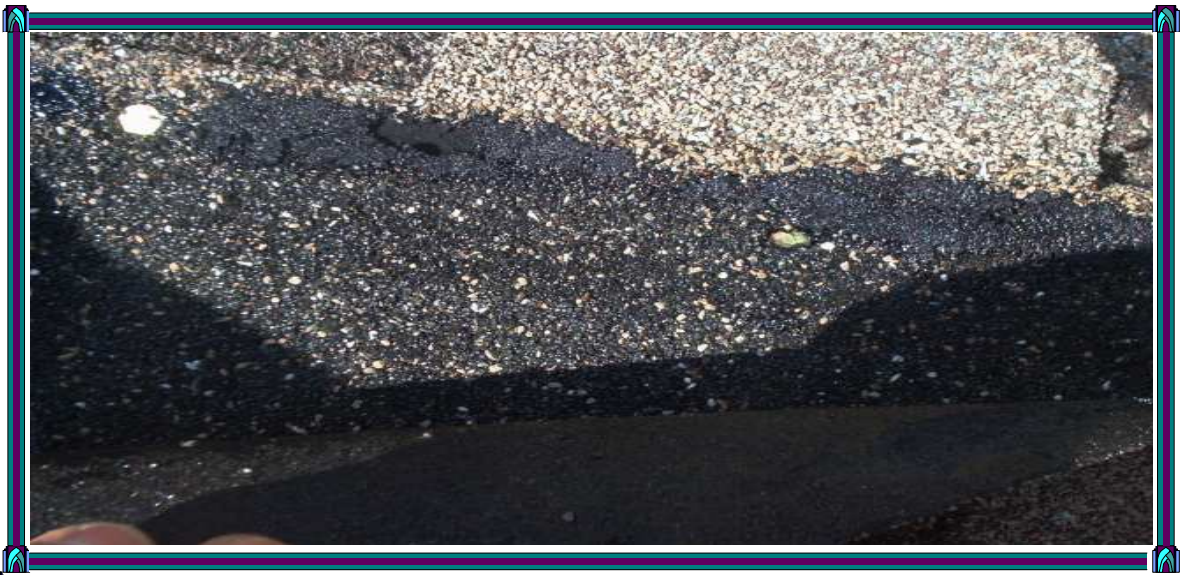
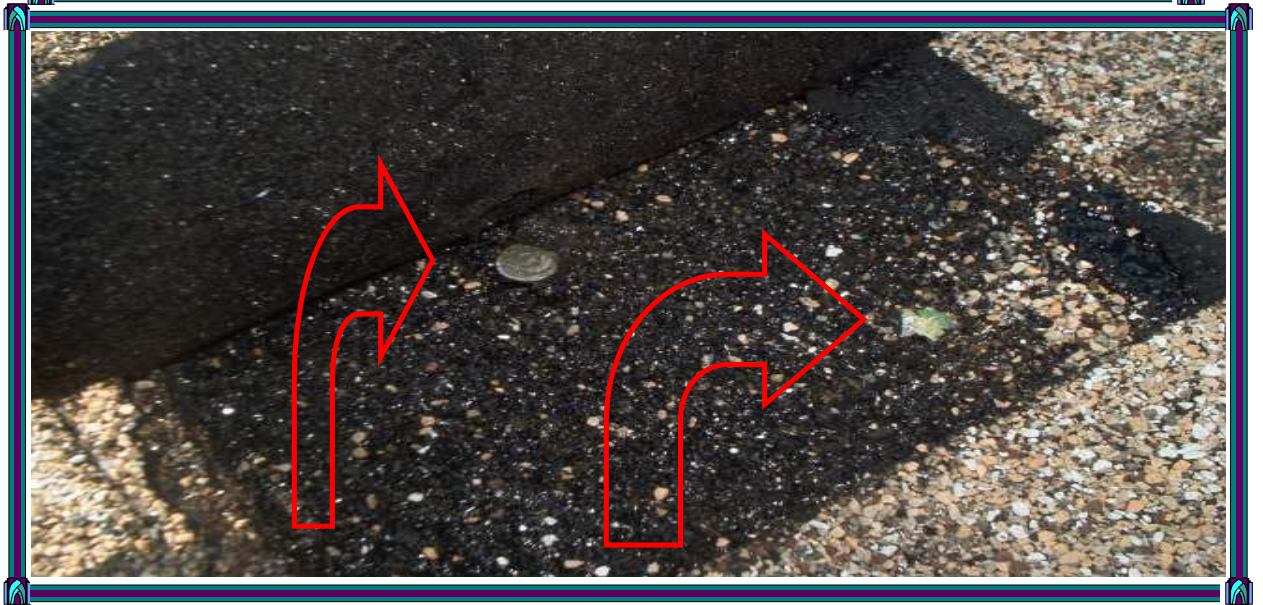
Under-driven nail and over-driven nail in field shingles.
