# MAGNUM

## I N S P E C T I O N S Inc.

### ROOF INSPECTION CONTINUED

A new roof has been installed at the above property. The homeowner requested an inspection of the installation. Below are the results of that inspection.

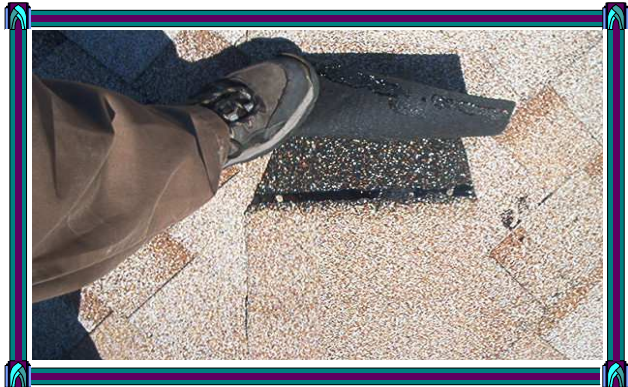
Numerous shingles are either overdriven, underdriven, or in some instances, not even nailed to the deck. This does not meet the manufacturers installation specifications or the South Florida Building code pertaining to the High Velocity Wind zone. These shingles may not stay in place under high wind conditions.

Shingles overdriven.

It is recommended that the entire roof be replaced to insure that proper installation methods have been used. Repair to any damaged wood should also be done as well as resealing any loose beams to the support walls. Proper permitting and inspections should be performed during each phase of the re-roof.

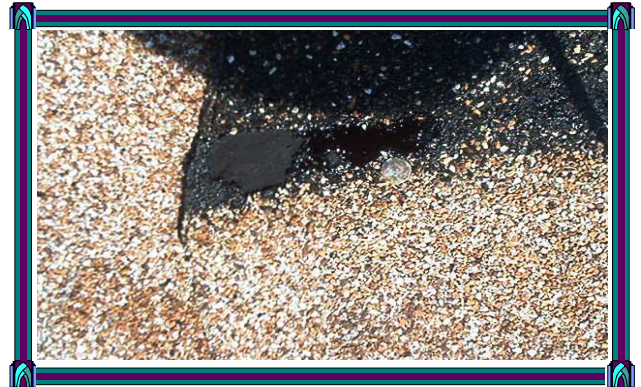
Shingles not nailed down.

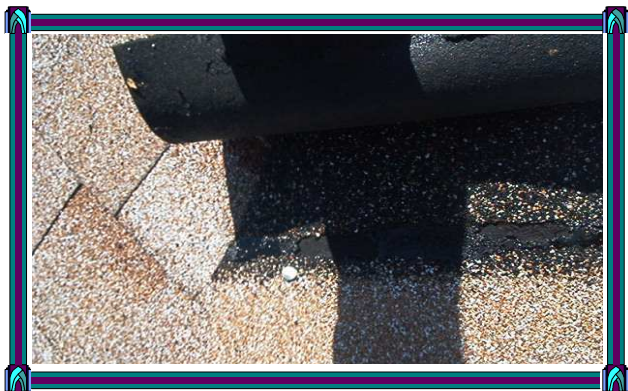
Shingles nailed in tar strip.

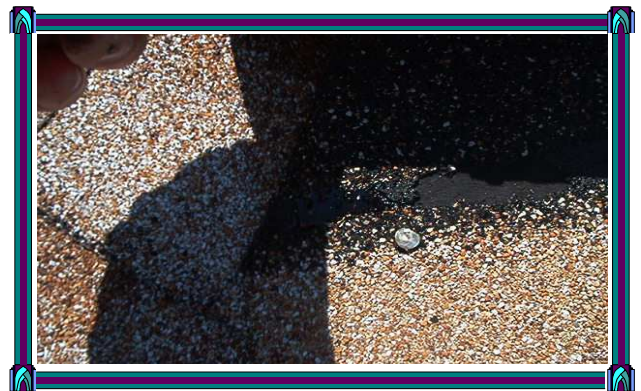
Nail not driven deep enough and shingle is sticking up.

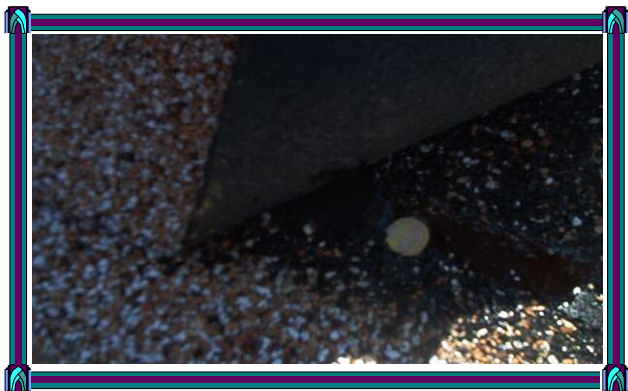
Nail not driven deep enough.

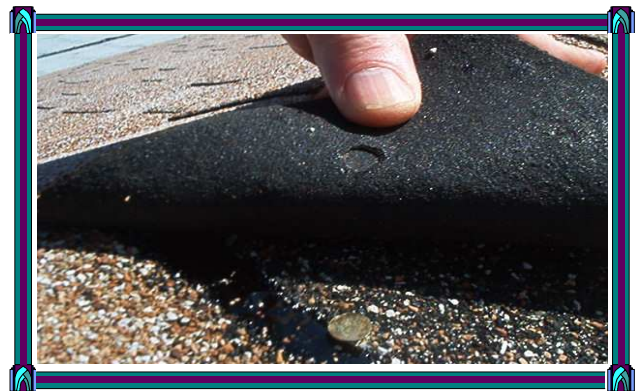
Nail not driven deep enough.

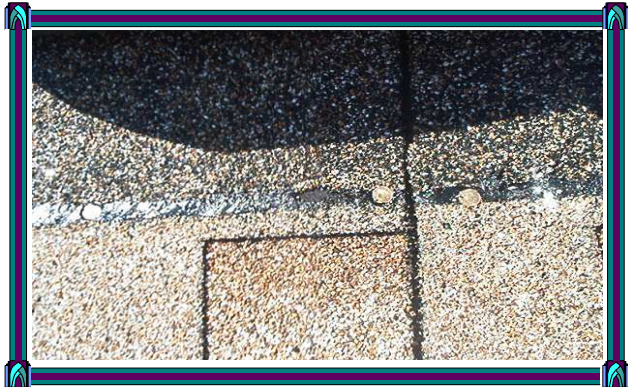
Shingles nailed improperly. Nails are required to be at least 1 1/2 inches from the edge.

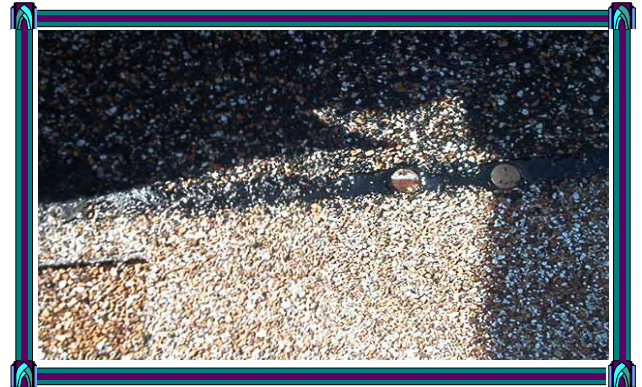
Nails in the center of the shingles are not spaced apart.

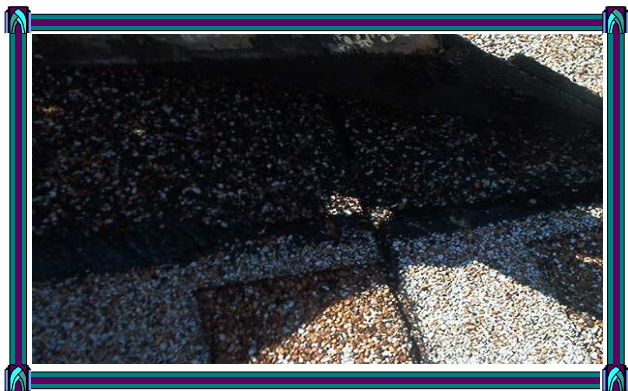
No nails.

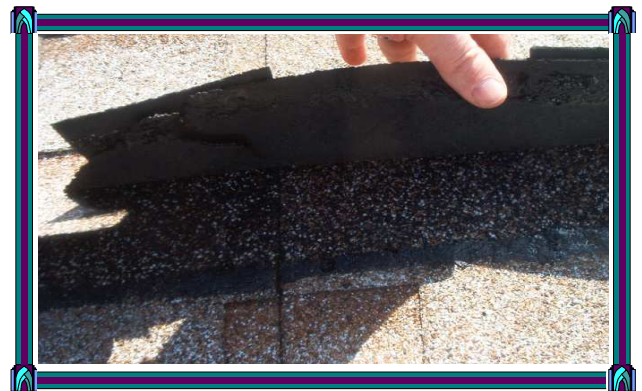
No nails.

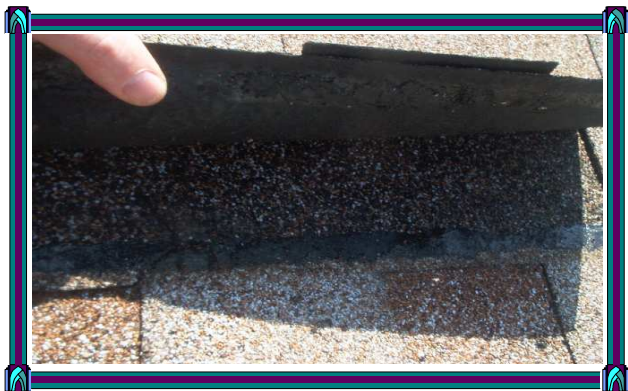
No nails

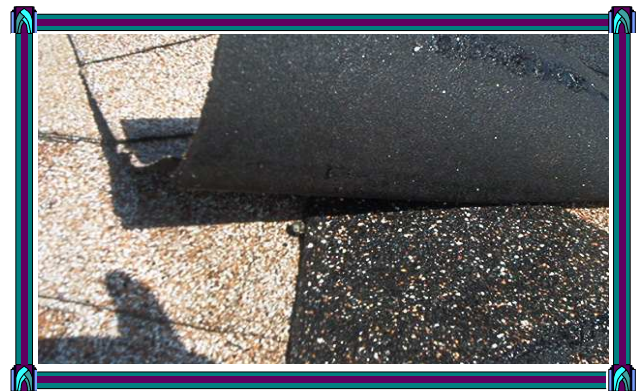
Nail missed shingle.

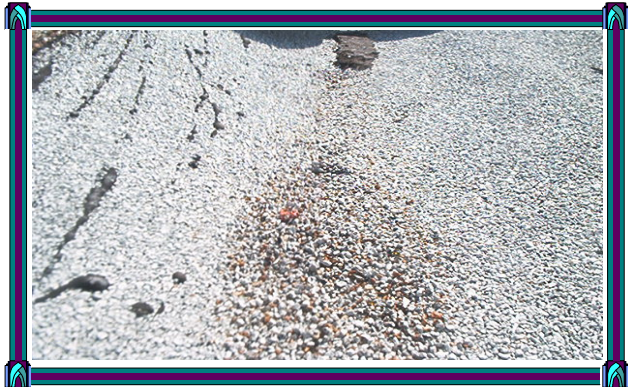
There is a "spongy" area at the center rear of the rear flat roof. This is most likely due to damaged decking/support members. Both roofs appear to have been installed with foam underneath the roof covering. As a result, there are numerous areas of low spots which will collect water and wear the roof out prematurely. The flashing has been damaged at the rear flat roof due to the gutter installation.

Dip in front flat roof where water has collected.

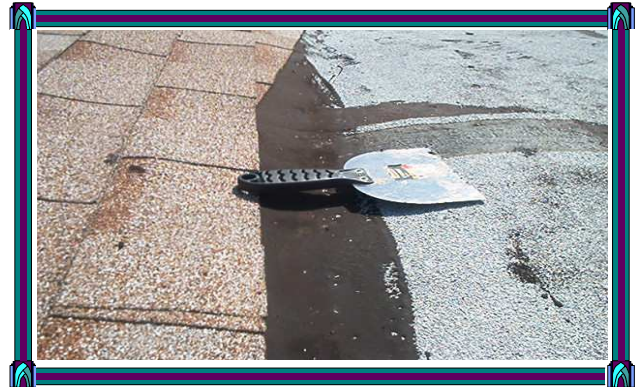
Hump in front flat roof which has cause a valley to form and water ends up in the previous dip.

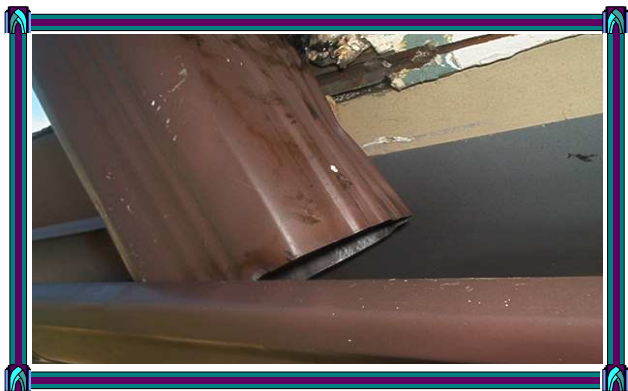
Improperly flashed sheathing at right front entrance porch.

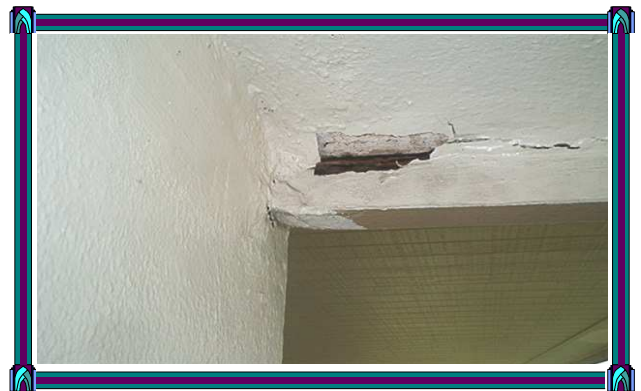
There were several areas of damaged wood (front , side, and rear fascia, sheathing at front valley) that were not replaced during the re-roof.

Damaged fascia at front entrance.

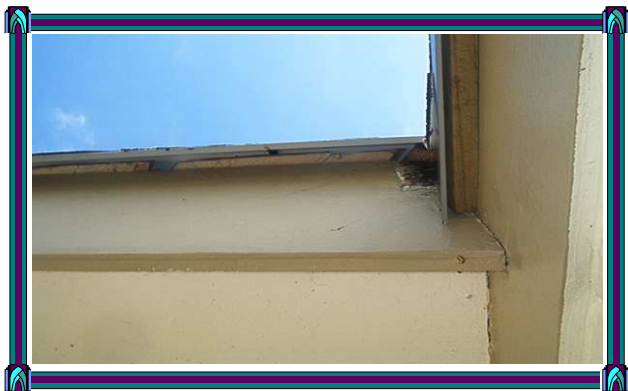
There were several areas of missing drip edge under the drip edge flashing. The purpose of the drip edge is to keep the metal flashing away from the fascia. Without the drip edge, the flashing is diverting the water directly onto the fascia which will cause it to rot.

There were two voids present at both sides of the front porch. The flashing was not installed flush against the fascia, in fact, the fascia was not added to this area which would have eliminated the void altogether.

Missing drip edge and void at left front of porch.

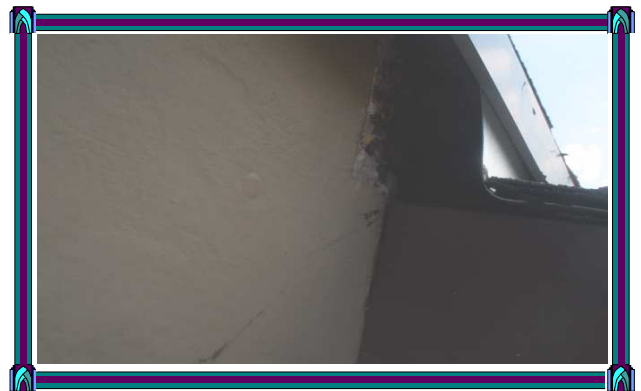
Void at left side of front porch.

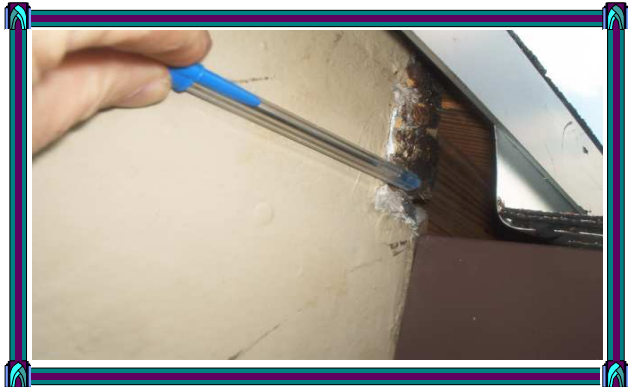
Void at left side of front porch.

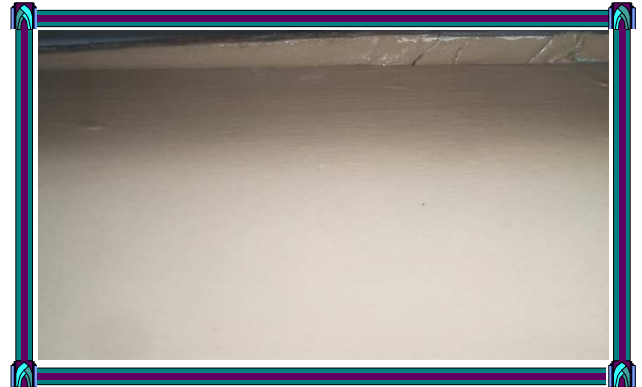
Missing drip edge at left front of house.

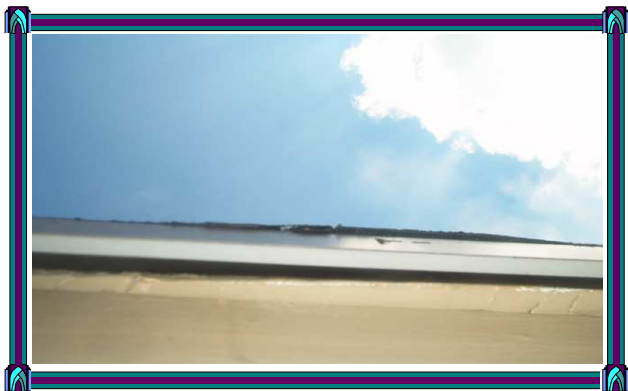
No drip edge at rear of roof.

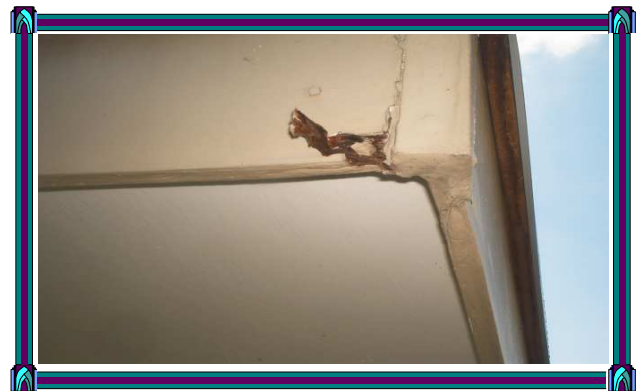
Rotted fascia at left side eof house.

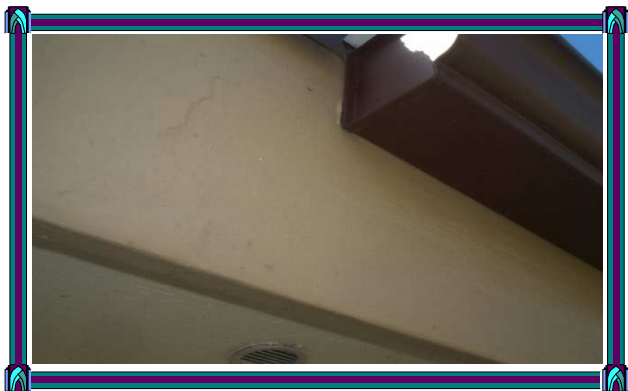
Damaged flashing at rear of house due to gutter installation.

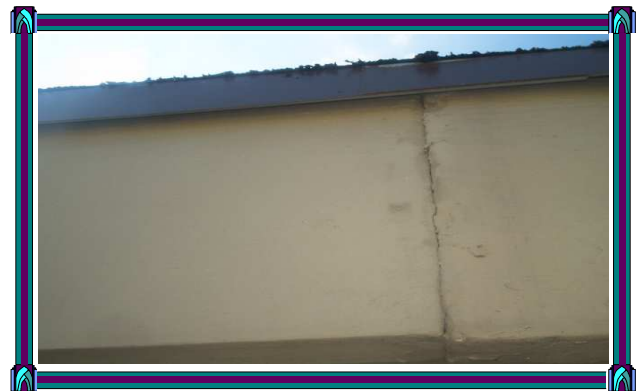
No drip edge at rear of house.

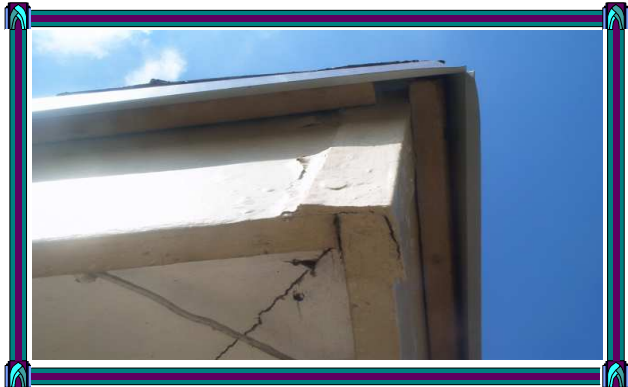
Missing drip edge and rotted fascia at rear of house.

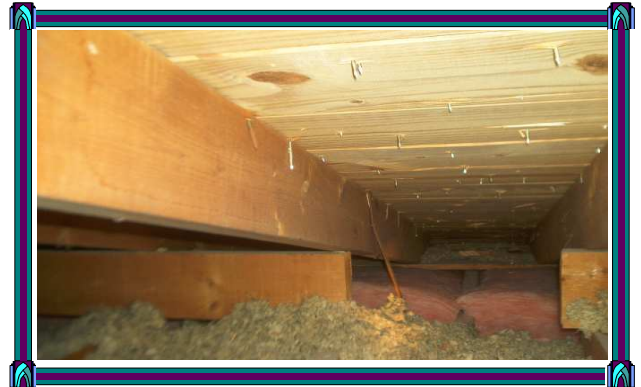
There were numerous nails that have missed the trusses in the attic. This does not meet the new nailing pattern. Although nails may have been installed next to the missed nails, there is no way to know without removing the roof coverings.

Numerous nails that have missed the beams.

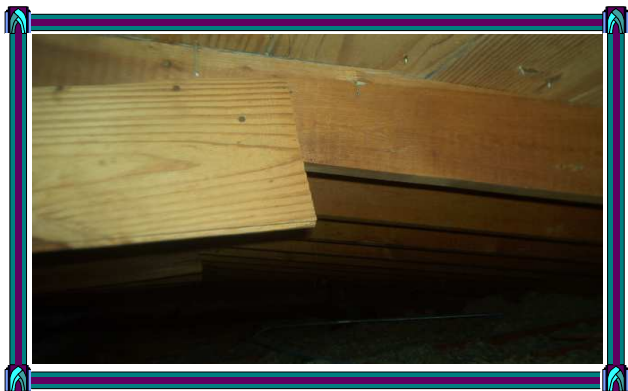
Nails that have missed the beam.

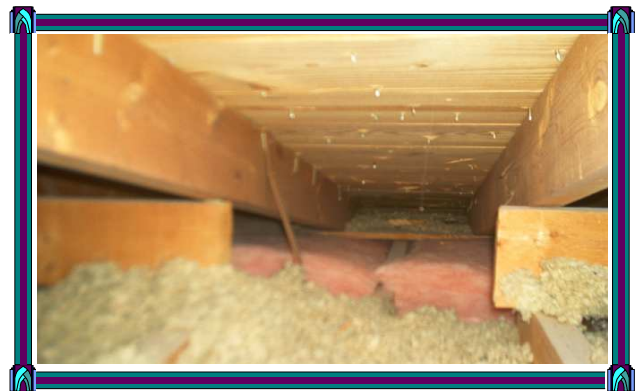
More nails that missed the beam.

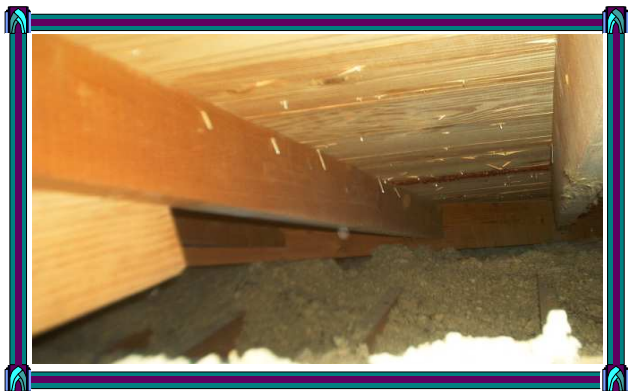
More nails missed the beam.

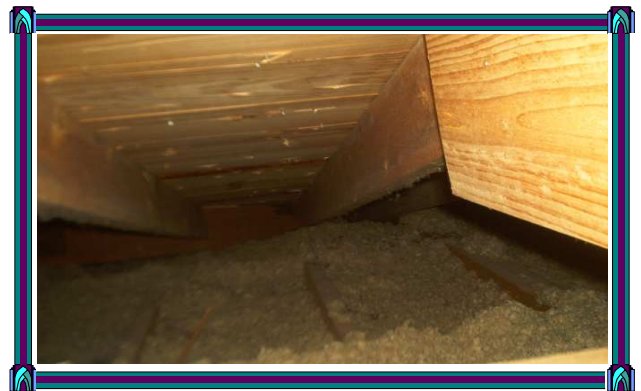
There were two braces that were broken in the attic. These braces are attached to two beams which are not secured to the support wall. There is a gap between the beams and the wall which was visible from the attic. When standing on this area on the roof, it is "bouncy". One turbine fan was not functioning and was installed crooked.

Beam that is not secured to the support wall.

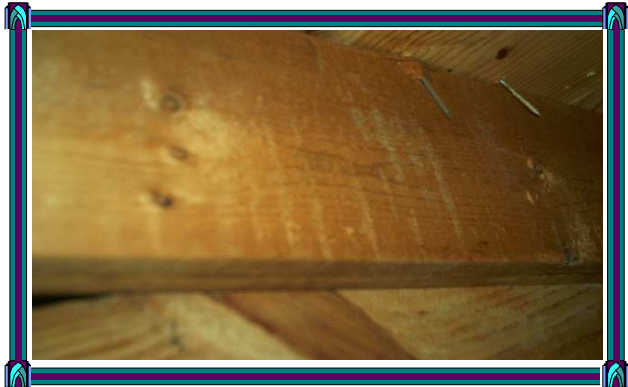
More missed nails.

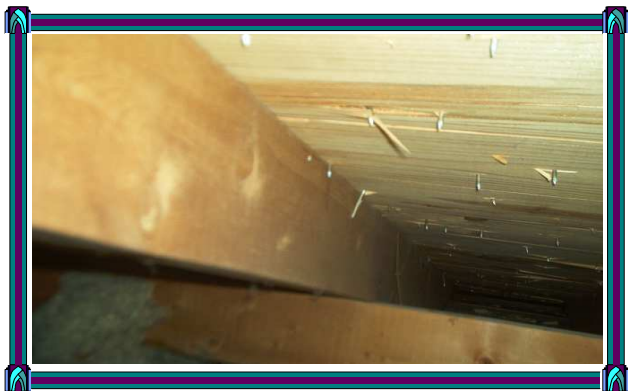
More missed nails.

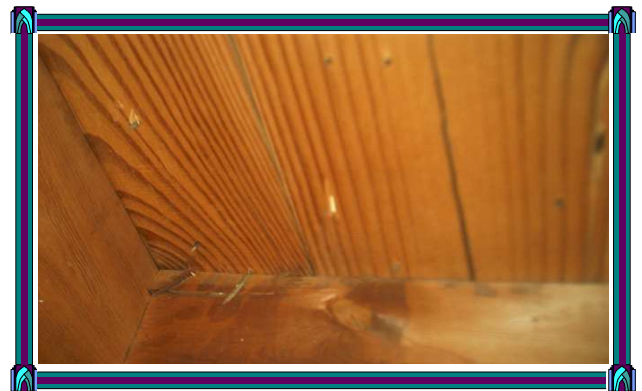
More missed nails.

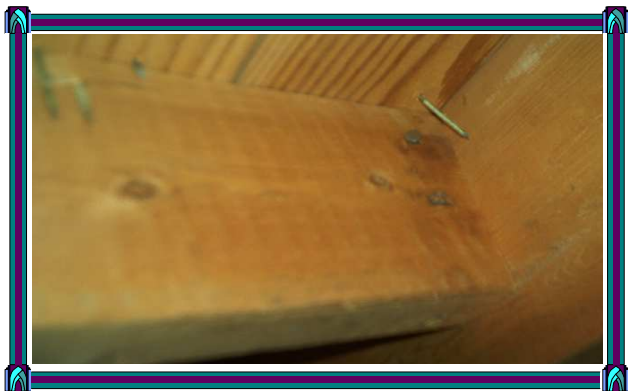
More missed nails.

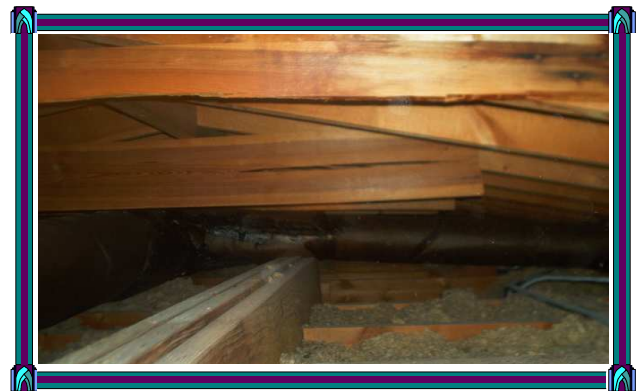
Broken support at center of attic on beam that is not secured to the support wall.

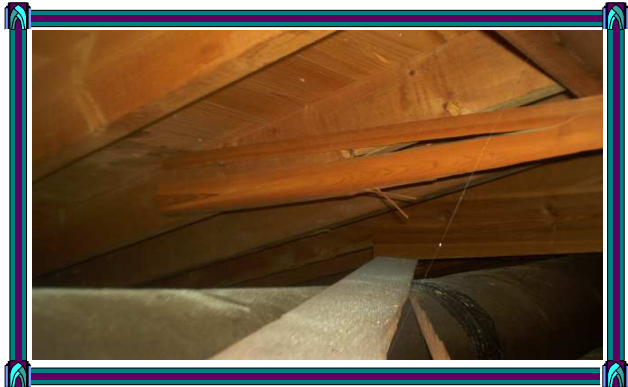
Broken support at another beam that was not secured to the support wall.

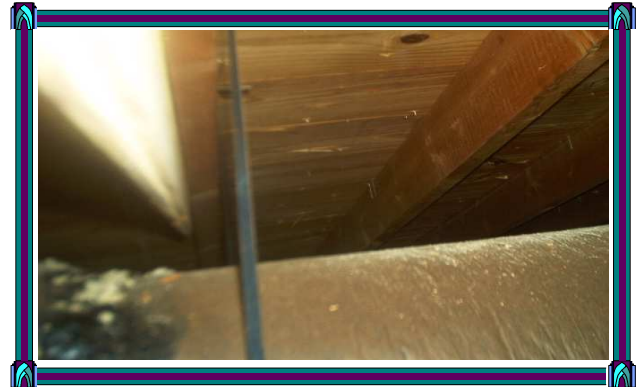
Other beam that is not secured to support wall.

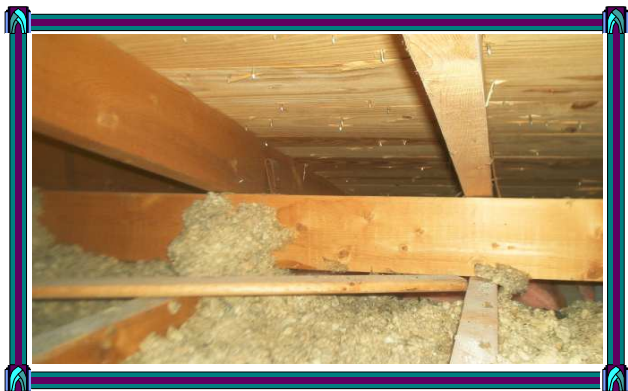
Missed nails.
