## INSPECTIONS Inc.

**Client:** Mr. Roof

**Date:** January 21, 2012

### Roof System

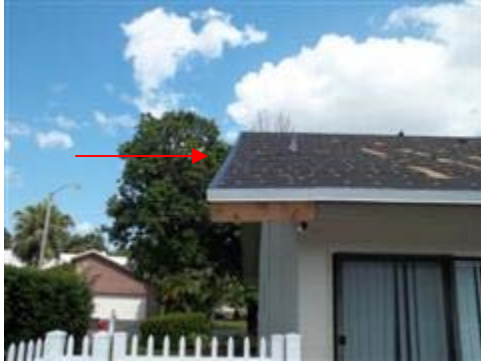
Right rear side off roof decking was sloped over the edge of the support wall.

**Recommendations:** It is recommended that all damaged wood be replaced. That the rear areas of decking that have sloped over the support walls be re-supported. That the hole for the bathroom vent fan line be enlarged to accommodate the other two bathroom vent fan lines. That the remaining nails that have missed the trusses be removed and the decking be re-nailed as per the local building code. That the tar paper that has been cut be re-installed flush and not over the slits in order to have a flat surface for the next layer of underlayment After the above corrections have been made, then, the peel and stick underlayment can be installed and the roof tiles attached as per the local code.

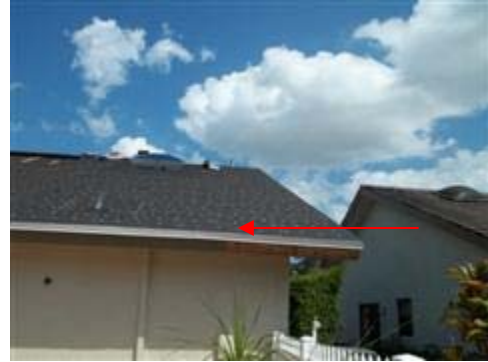
Left rear side off roof decking was sloped over the edge of the support wall.

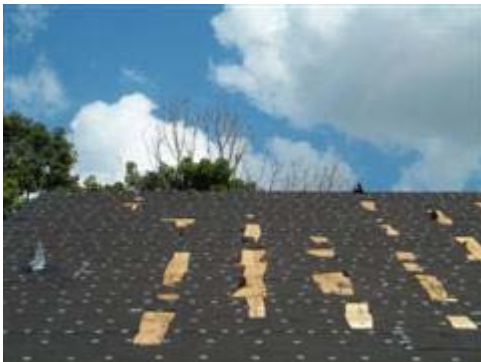
The tar paper has been cut in numerous areas in order to facilitate removal of the nails that missed the trusses.

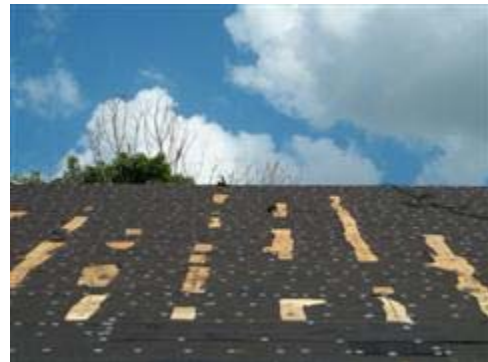
The tar paper has been cut in numerous areas in order to facilitate removal of the nails that missed the trusses.

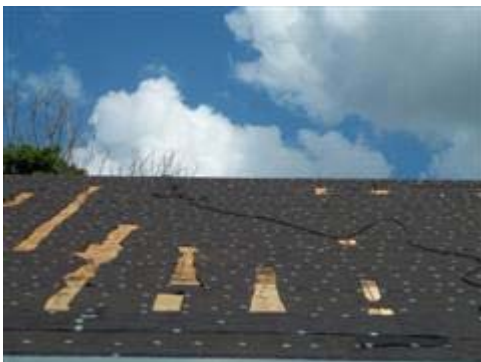
The tar paper has been cut in numerous areas in order to facilitate removal of the nails that missed the trusses.

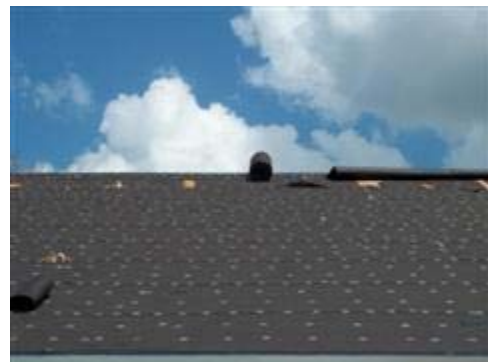
The tar paper has been cut in numerous areas in order to facilitate removal of the nails that missed the trusses.

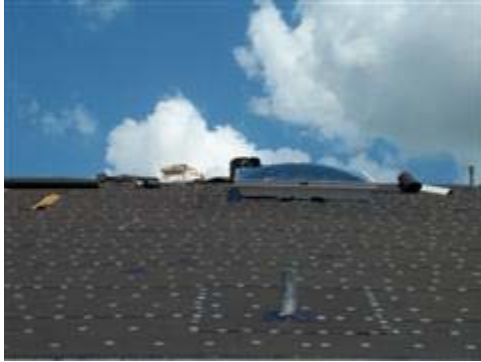
The tar paper has been cut in numerous areas in order to facilitate removal of the nails that missed the trusses.

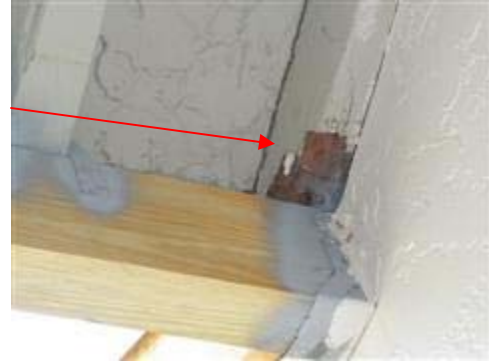
Damaged beam observed at front porch.

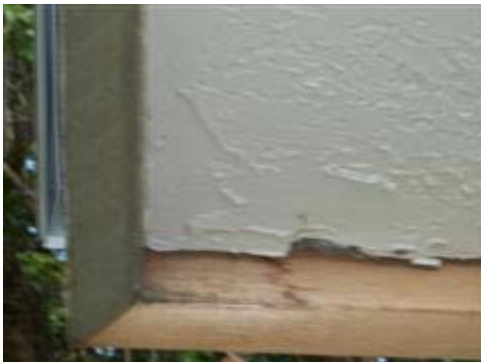
Evidence leak observed at right side front fascia.

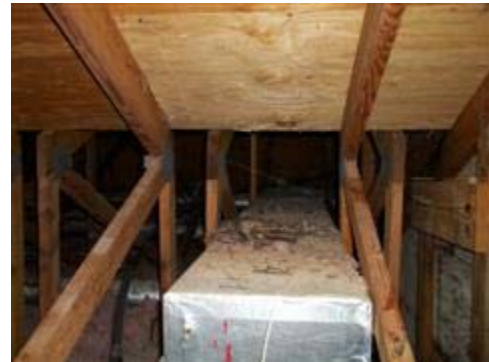
Debris scattered in various areas of the attic as well as on the a/c duct work.

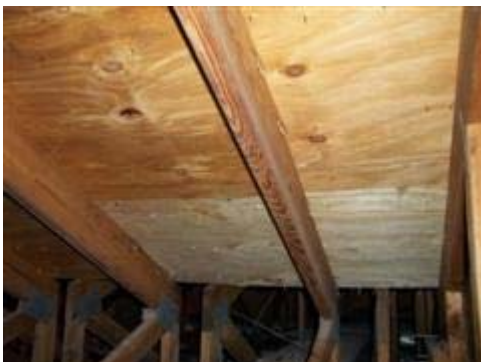
Debris scattered in various areas of the attic as well as on the a/c duct work.

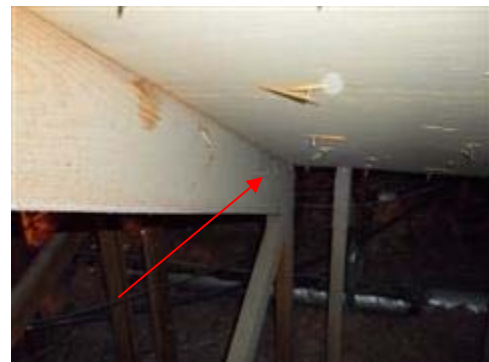
Several nails that missed the trusses were still present on mostly, the front portion of the roof.

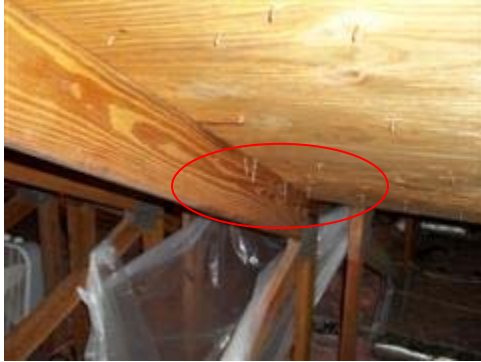
Several nails that missed the trusses were still present on mostly, the front portion of the roof.

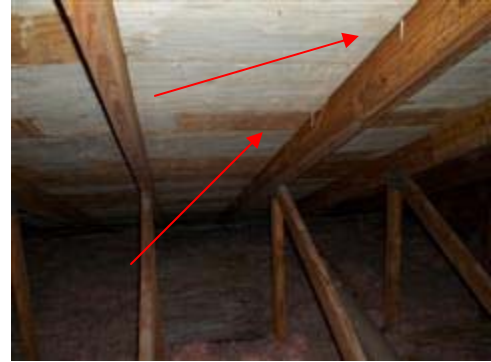
Several nails that missed the trusses were still present on mostly, the front portion of the roof.

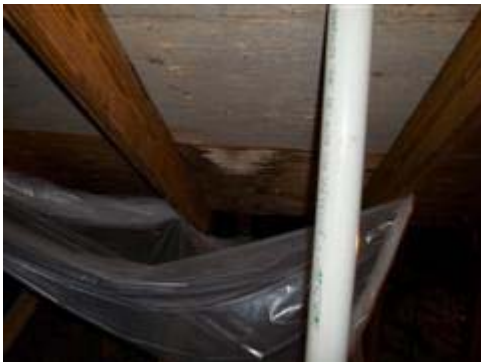
Damaged decking observed from what appears to be a roof leak at the garage vent stack.

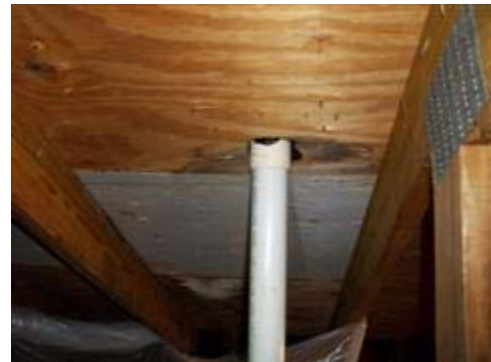
Damaged decking observed from what appears to be a roof leak at the garage vent stack.

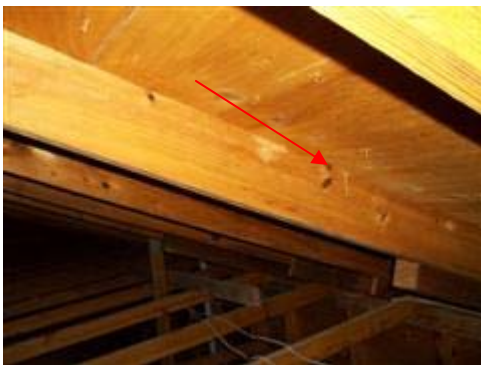
Several nails that missed the trusses were still present on mostly, the front portion of the roof.

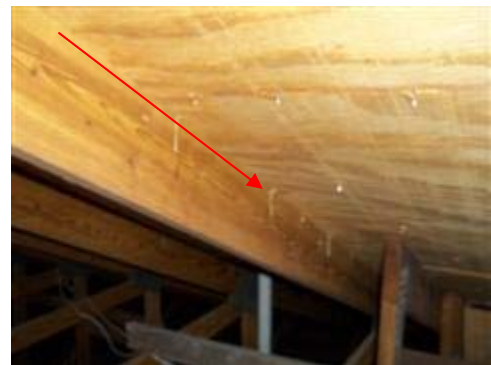
Several nails that missed the trusses were still present on mostly, the front portion of the roof.

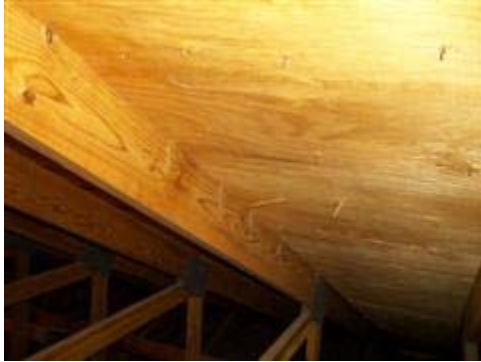
Several nails that missed the trusses were still present on mostly, the front portion of the roof.

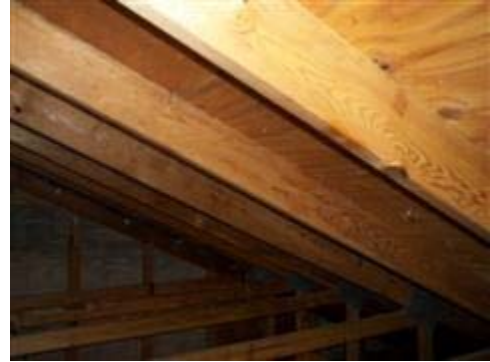
Several nails that missed the trusses were still present on mostly, the front portion of the roof.

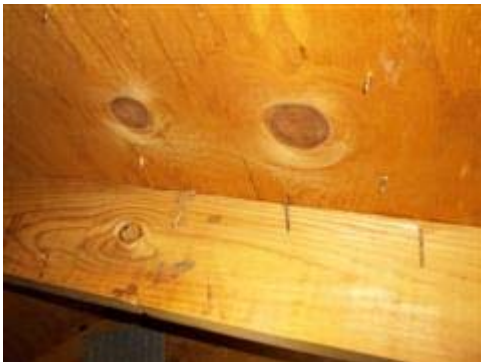
Several nails that missed the trusses were still present on mostly, the front portion of the roof.

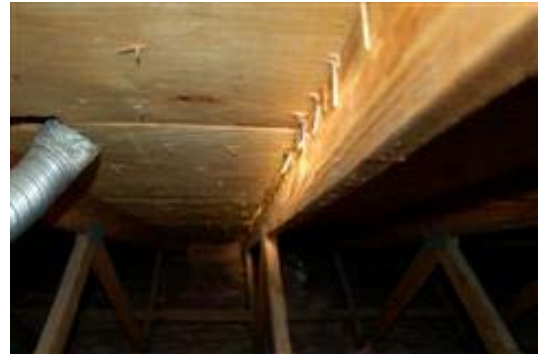
Hole for vent bathroom vent fan line should be enlarged to accommodate the two other bathroom vent fan lines.

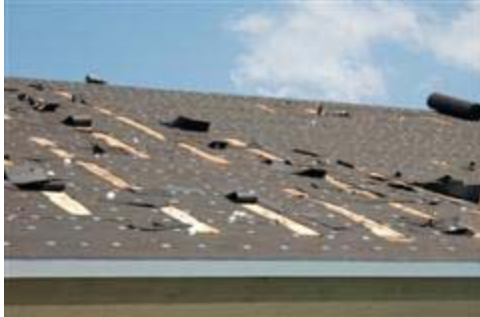
It would appear as though in order to correct the nailing issue, several slits have been cut out of the roof and then patched. It would also appear as though another layer of tarpaper has been added over the first layer. Unfortunately, the roof no longer has an even surface to apply anything else to.

Roof nail repairs.

At this point, it would be recommended that all of the roof coverings be removed and then, new underlayment be installed as per the local building code.

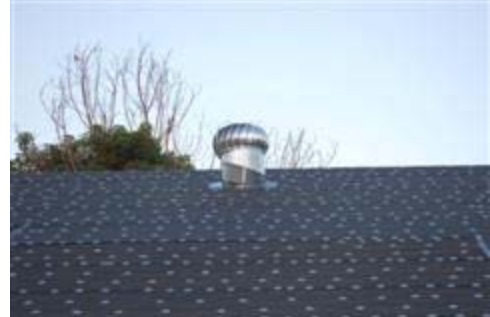
Uneven tarpaper.

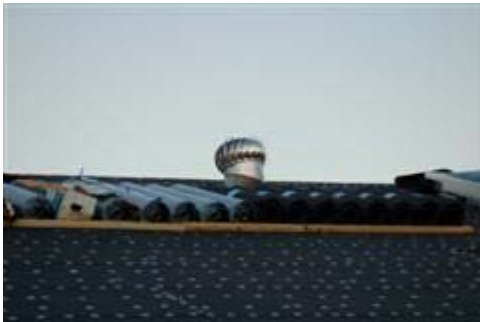
Uneven tarpaper.

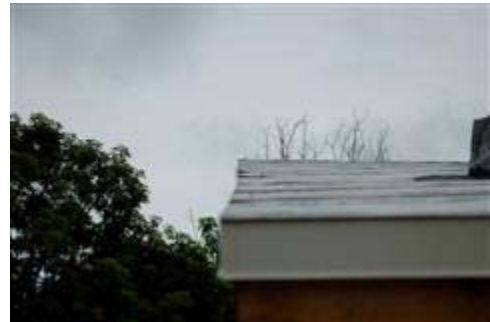
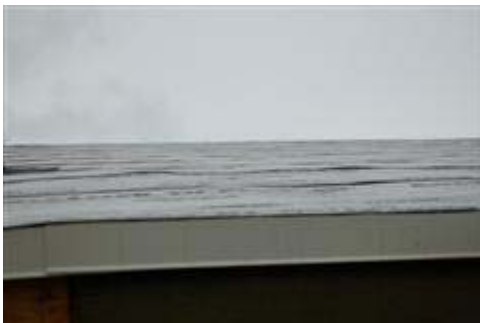
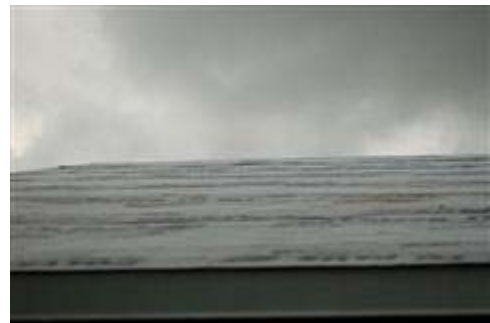
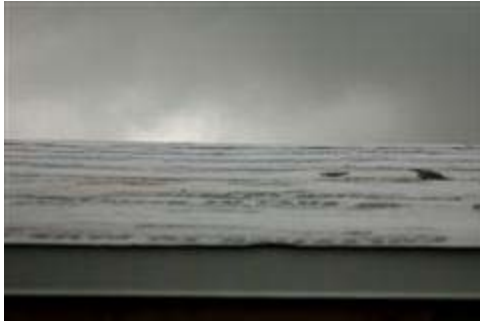
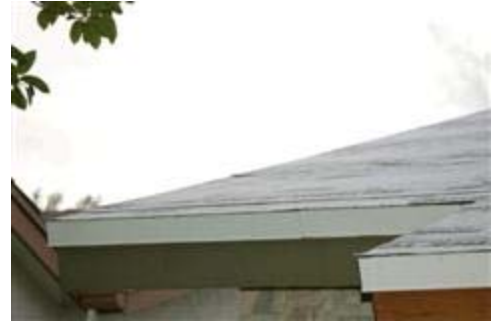
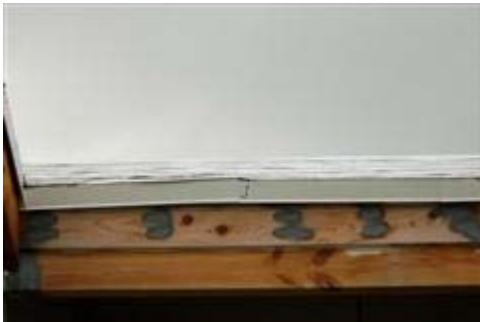
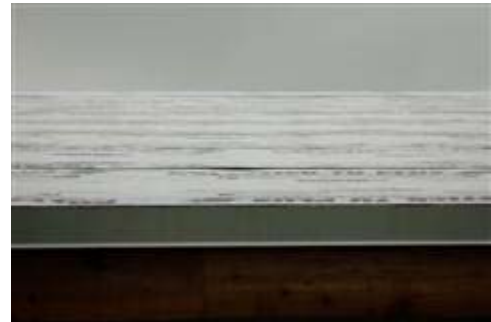
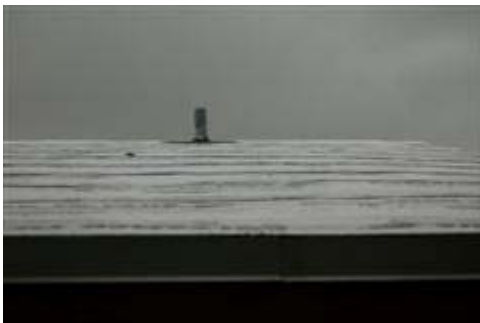
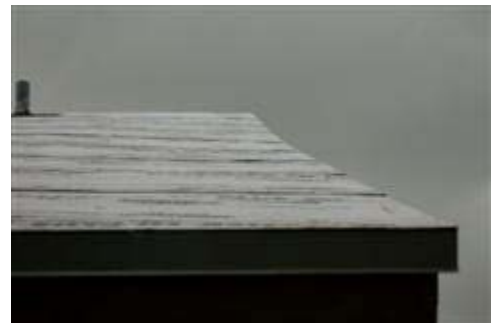
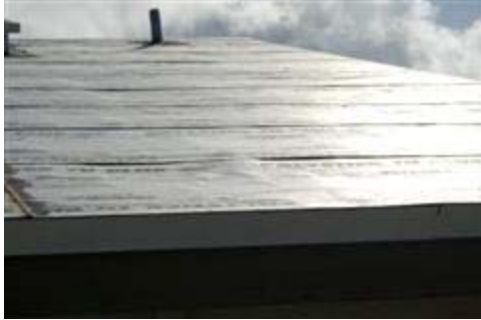
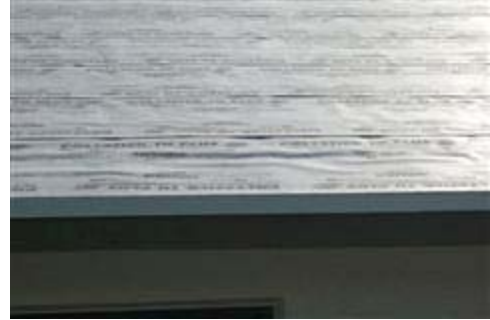
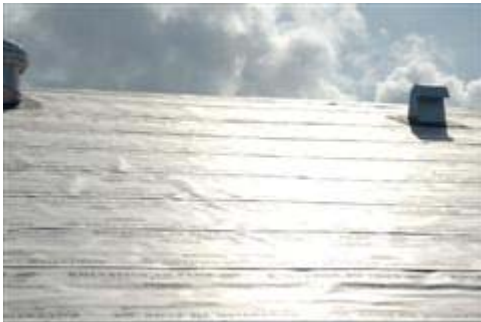
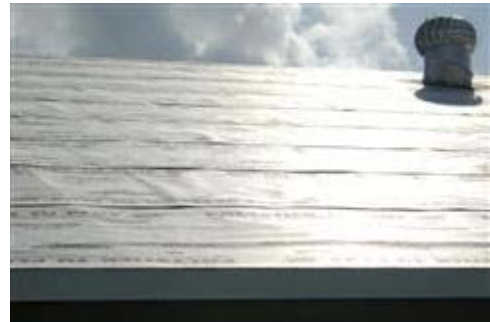
The peel and stick membrane has been added and due to the unevenness of the underlayment, various dips are present as well as bubbles in the material, which would indicate improper rolling during installation, as well as several areas that are not adhered to the underlayment. As per the manufacturer: **4. Polystick membranes shall be applied to a smooth, clean and dry surface. The deck shall be free of irregularities.**

Membrane not adhered properly.
