NAME: Margate roof
DATE: June 6, 2007

ROOF

METHOD OF INSPECTION: Walked on roof, crawled attic where accessible.

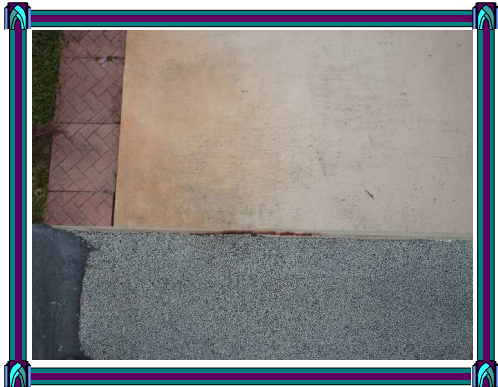
Rusted out flashing observed at flat roof.

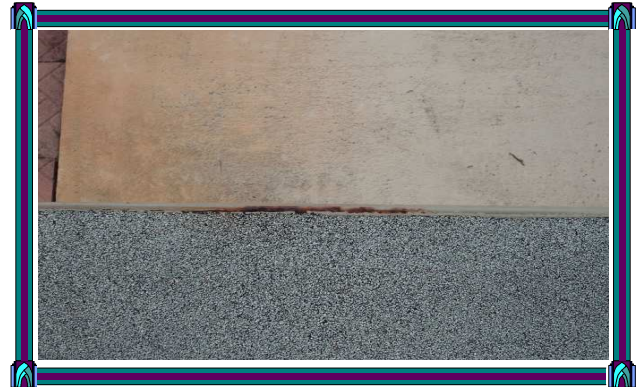
Close up of rusted out flashing at flat roof.

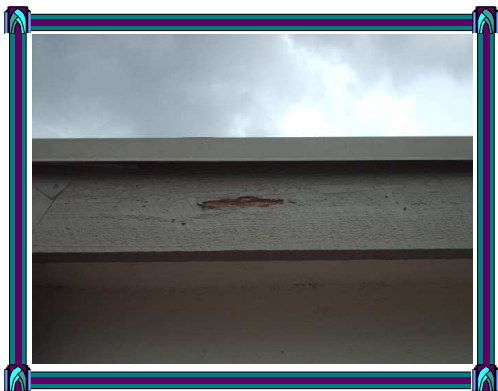
Rotted fascia at flat roof.

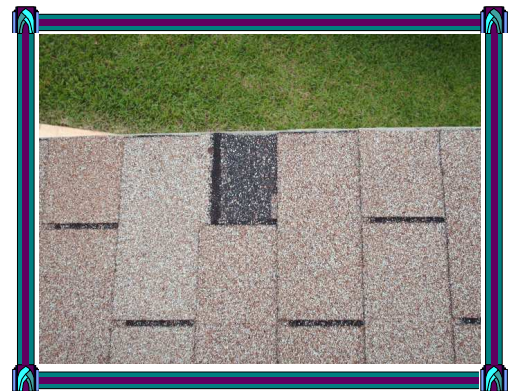
Missing shingle observed on main roof.

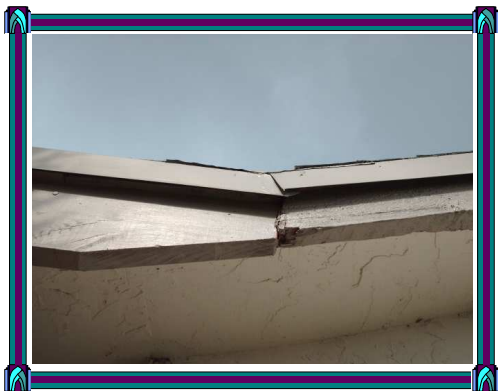
Rotted fascia observed on main roof.

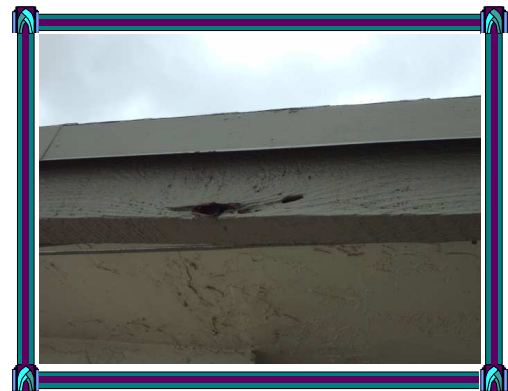
Rotted fascia observed at front of house.

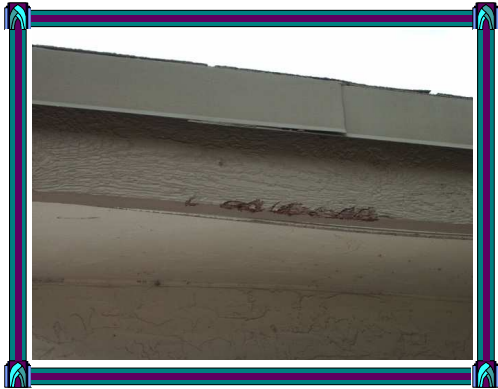
Damaged fascia observed at left side of house.

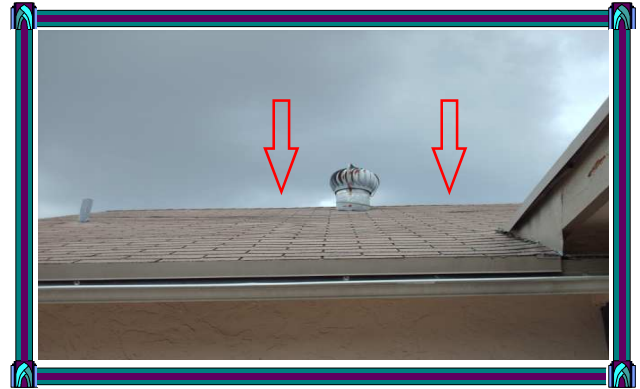
There were two distinct "dips" in the plywood decking at the rear of the main roof.

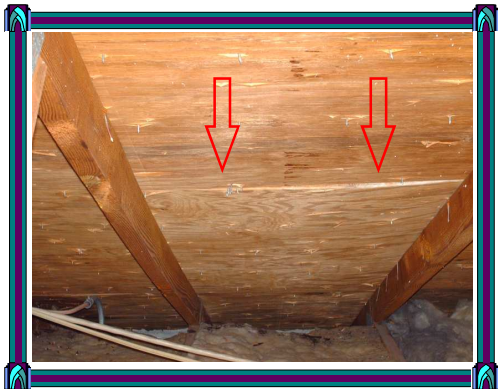
The "dips" were caused by sagging plywood observed from the attic.

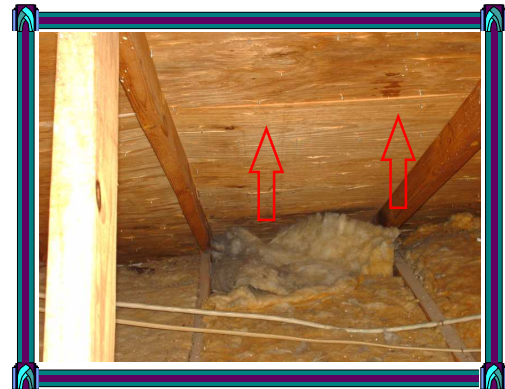
The second area of sagging plywood.

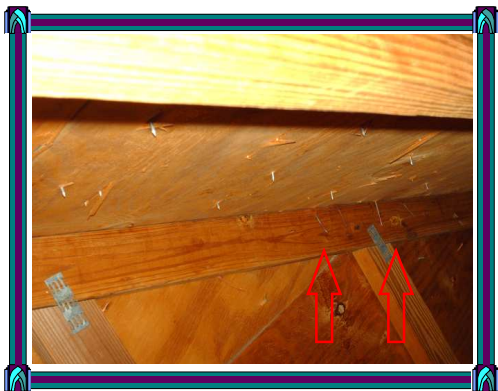
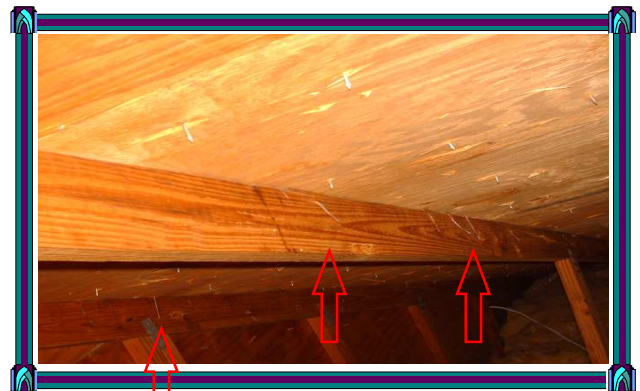
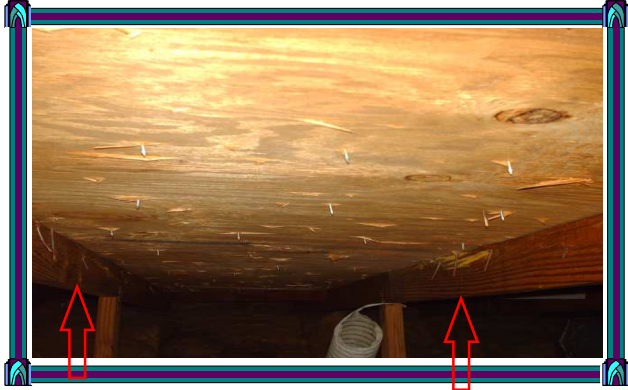
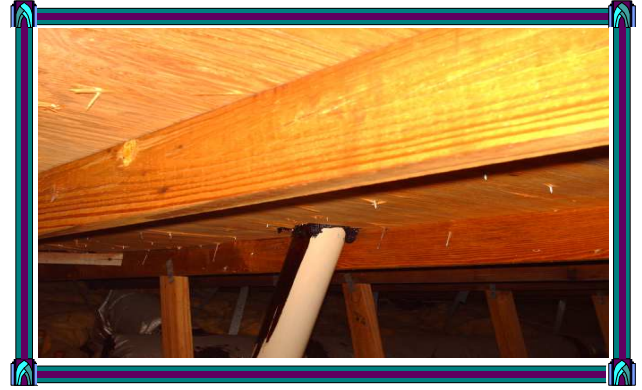
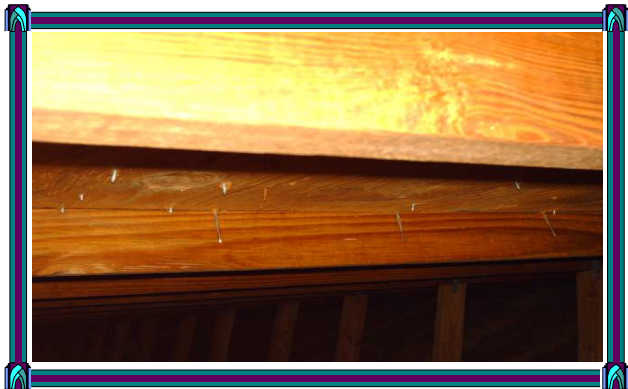
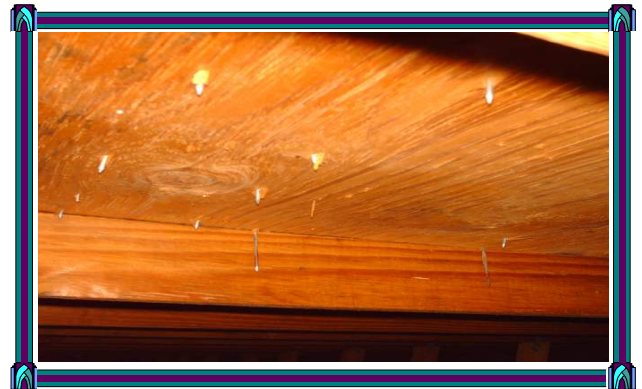
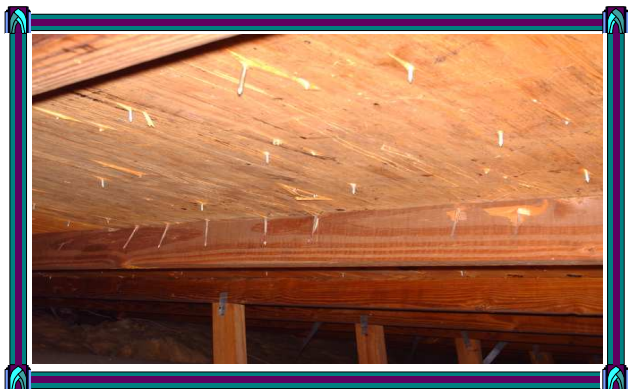
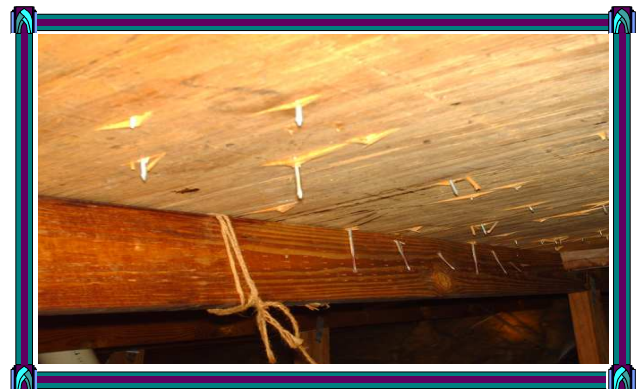
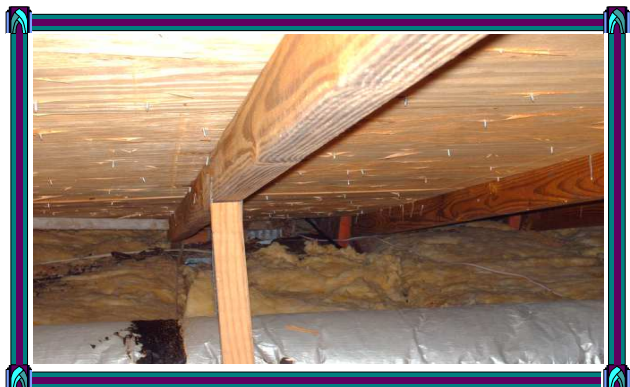
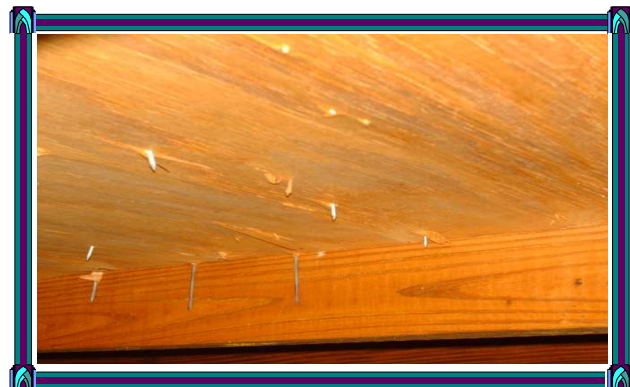
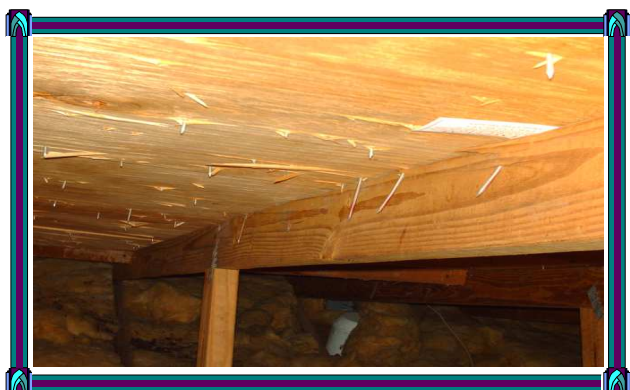
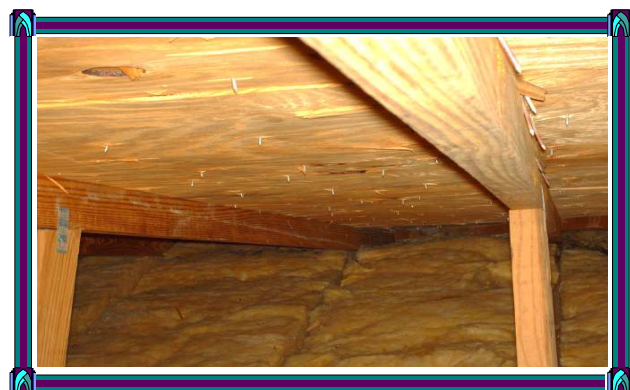
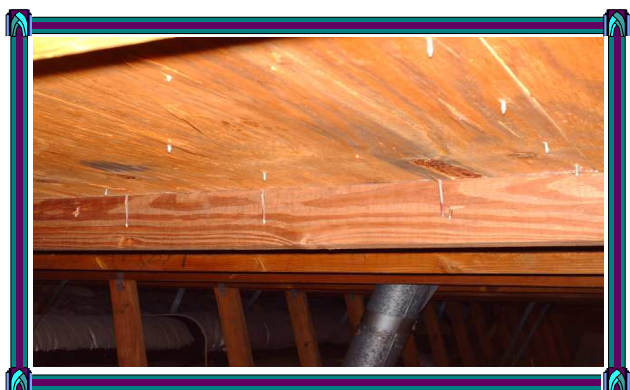
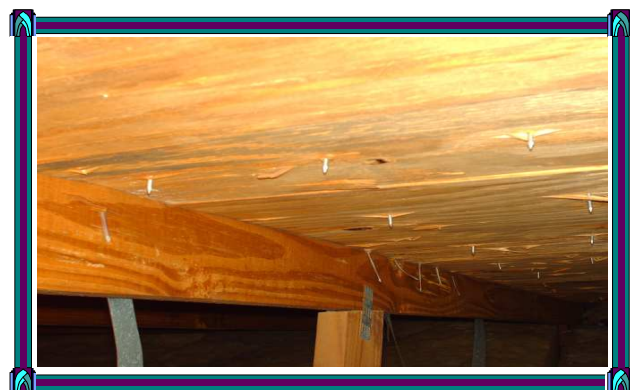
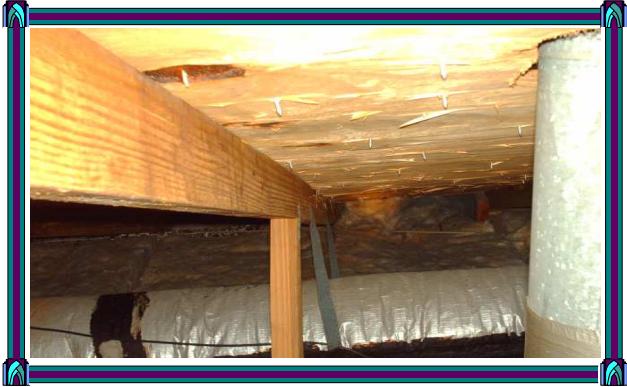
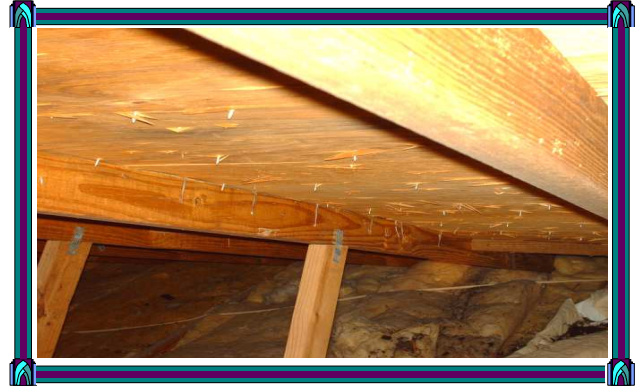
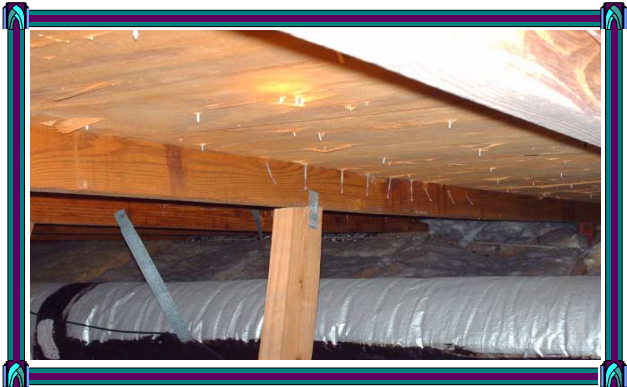
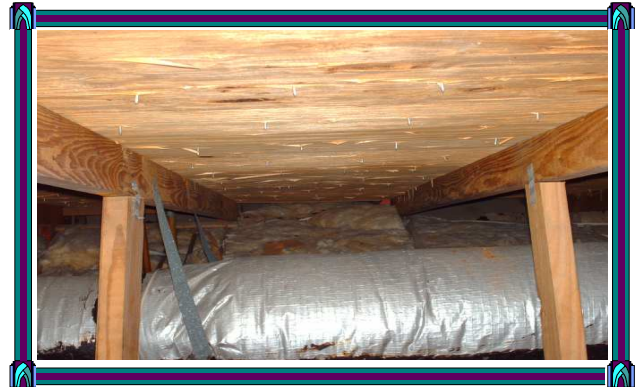
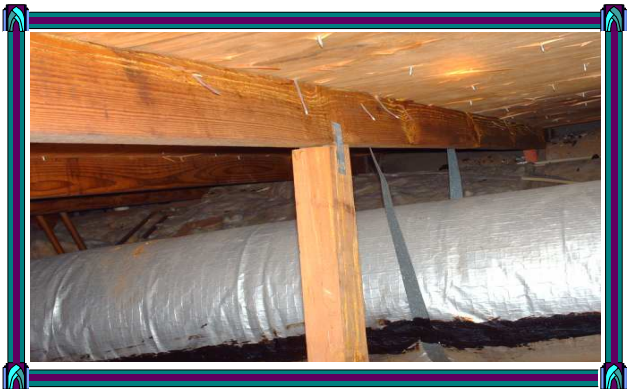
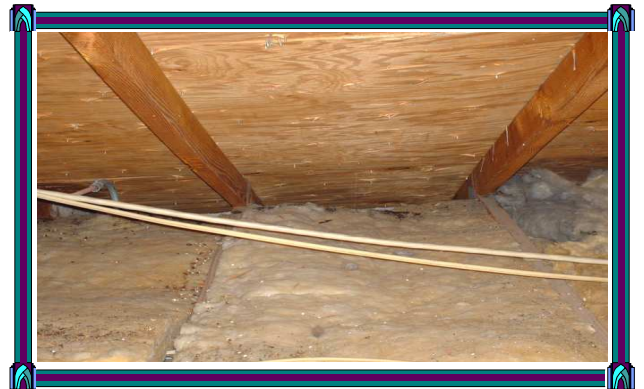
The remaining photos are of the numerous nails that have missed the roof trusses. This does not meet the APA guidelines for decking installations.
