I N S P E C T I O N S Inc.

NAME: Name removed
DATE: February 24, 2006

ROOF

A roof inspection was performed at the above address at the request of the home owners. Below, are the results of that inspection.

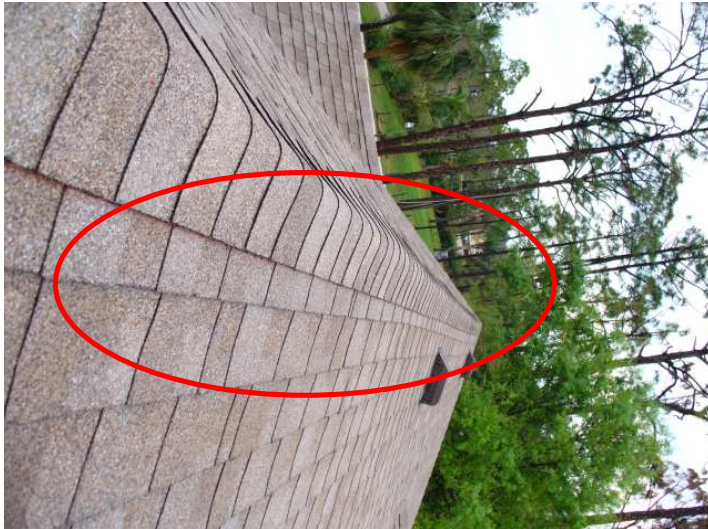
The roof shingles are 40 year Timberline architectural shingles. There are several areas where the shingle installation is “wavy”. There is an installation line present on the shingles with a maximum amount of variance. The installation of the shingles does not fall within those guidelines and therefore does not comply with the manufacturer’s installation specifications (see attached).

Uneven row of shingles on front of roof.

It is recommended that the area of shingles that is “wavy” be removed and new shingles installed in accordance with the manufacturer’s specifications. In order to complete the repair, damage may result to the underlayment requiring further removal of additional shingles. An area of shingles should be removed over an area where the nails have missed the trusses. This area should then be visually inspected to determine if the proper nailing pattern has been executed. If the proper nailing pattern is not present, the home should be re-roofed. This would entail the following scope of work:

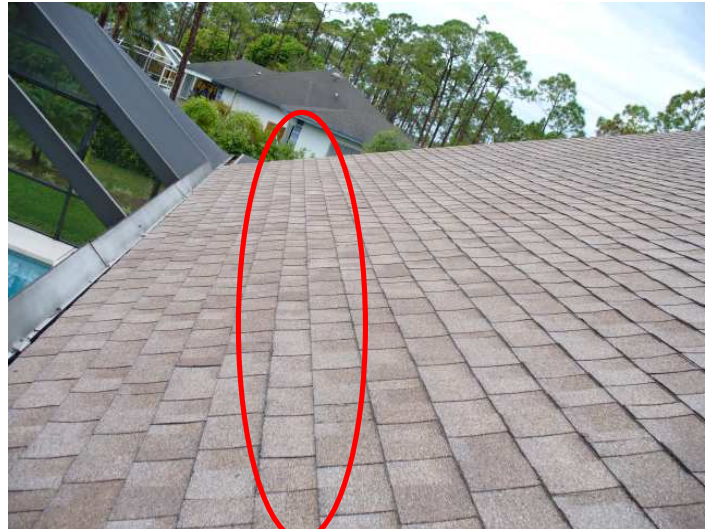
Uneven row of shingles on rear of roof

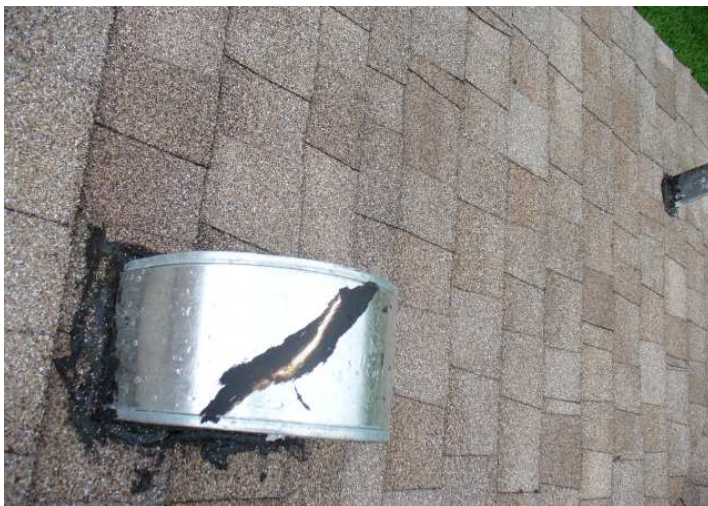
Cold process roof cement on vent.

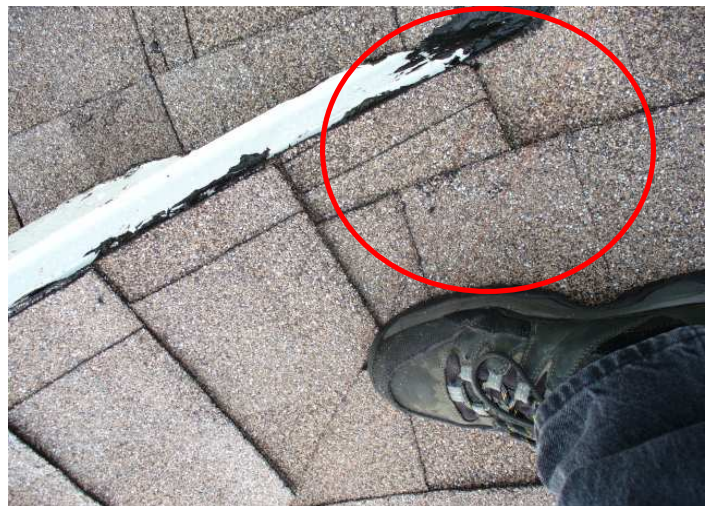
Cold process roof cement at valley.

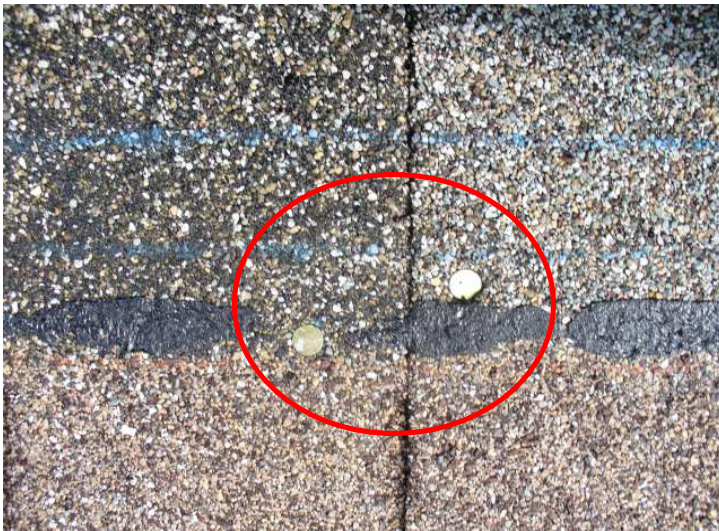
One nail too low, the other nail not nailed in far enough. There were several shingles installed in this manner.

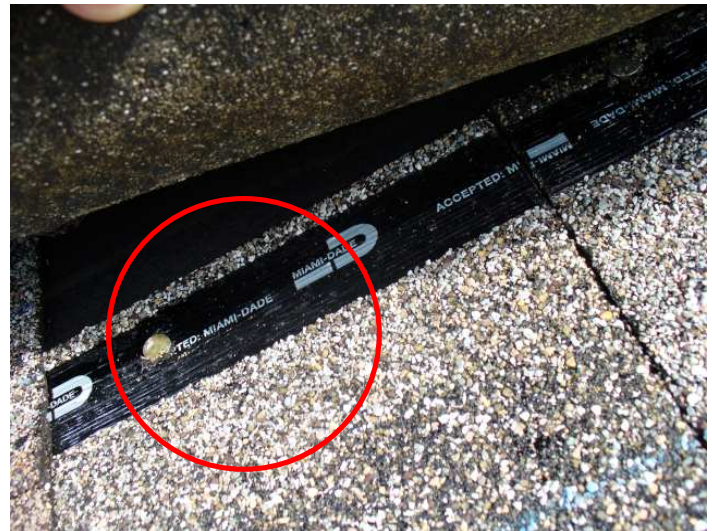
Nail in the rear strip. Several were like this as well.

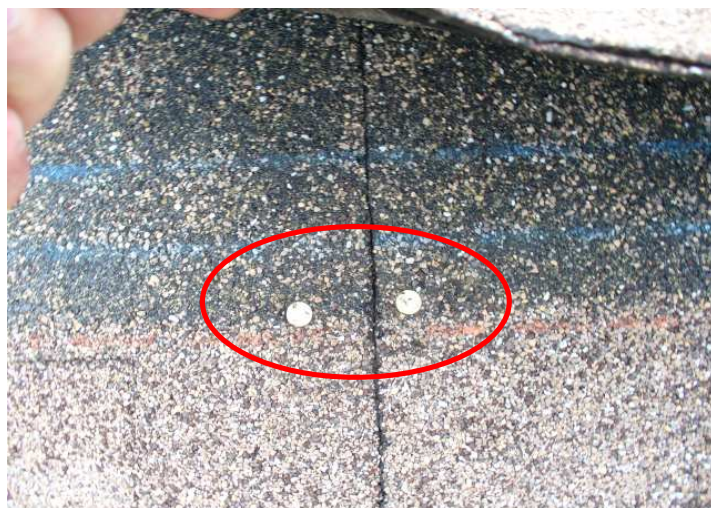
Nail too close to the edge of the shingle (1-1/2 inch required).

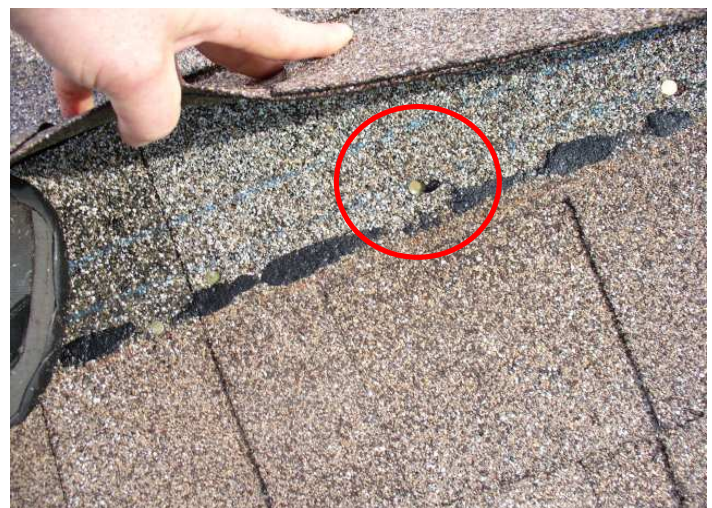
Nail over-driven through shingle. There were several nails over driven throughout the roof.

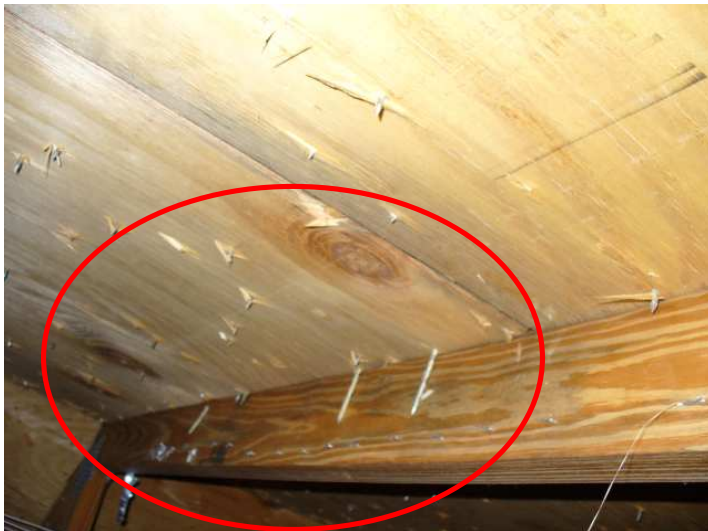
After visual inspection of the attic, there were numerous nails coming through the plywood decking next to the roof trusses. These nails were to be nailed into the trusses to comply with the new building requirement. It would appear as though the installer used an air nailer to install these nails and did not realize that he had missed several studs. This is the case, then the installation would not meet the code, the minimum standard, and therefore would not be compliant.

These nails may work their way upwards and break through the underlayment and possibly the shingles which would cause a roof leak. Of greater concern, is that if the nails were supposed to be used to secure the decking as per the local code and this was not done, is not only non-compliant, but may result in the loss of the roof decking under high wind conditions found in hurricanes.

During the re-nailing of the plywood, several nails missed the truss.

- 1 Remove the entire roof covering down to the decking.
- 2 Remove all nails that have not penetrated the trusswork verified by inspection of the attic.
- 3 Nail the plywood decking according to the local building code using a chalk line, if necessary to assure proper nailing.
- 4 Verify by visual inspection of the attic that the nails have been nailed into the trusses as per the local code.
- 5 Installation of underlayment, metal, vent stacks, etc. according to the local building code and the manufacturer’s specifications.
- 6 Installation of the shingles according to the manufacturer’s specifications.

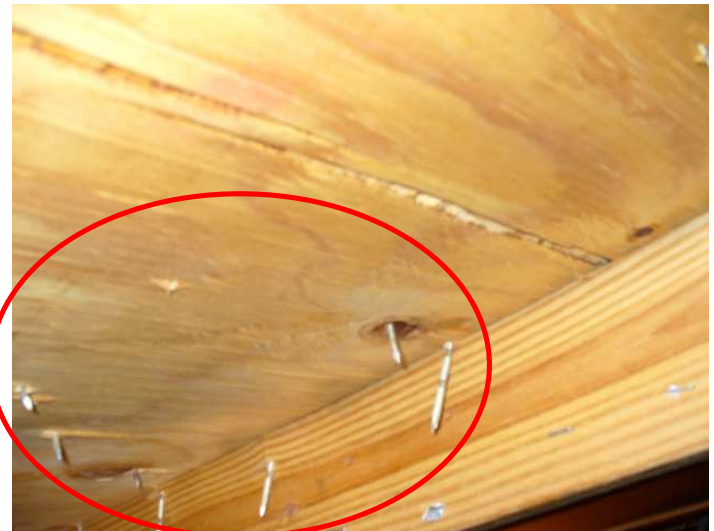
More missed trusses.

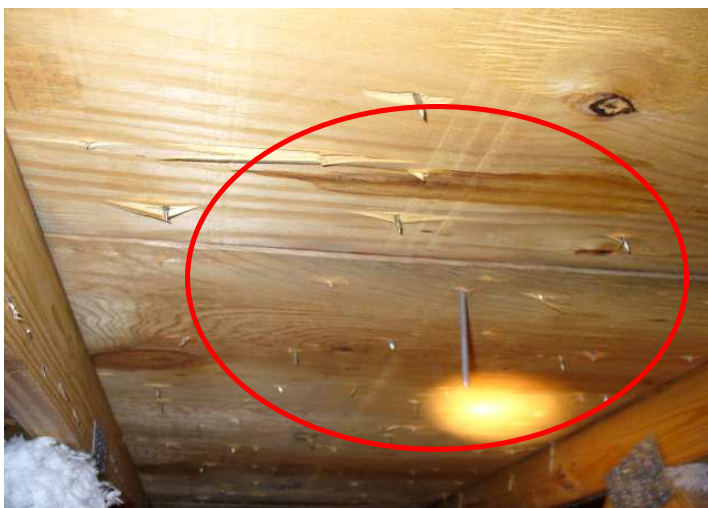
Not even close!

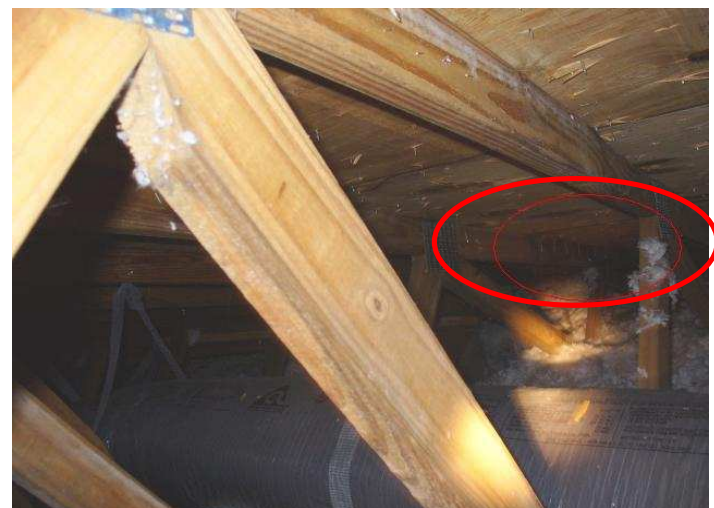
There are six nails that missed the truss in a 2 foot span. There were over 400 nails like this.
