## INSPECTIONS Inc.

### DEFICIENCY PHOTOS

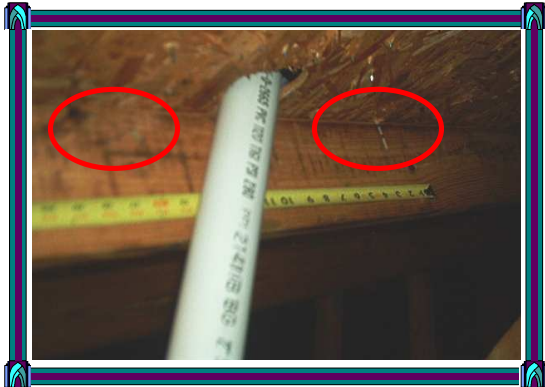
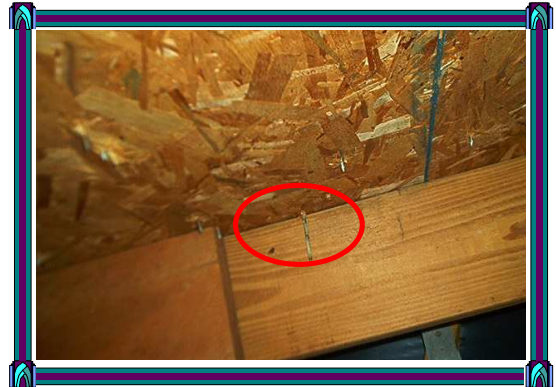
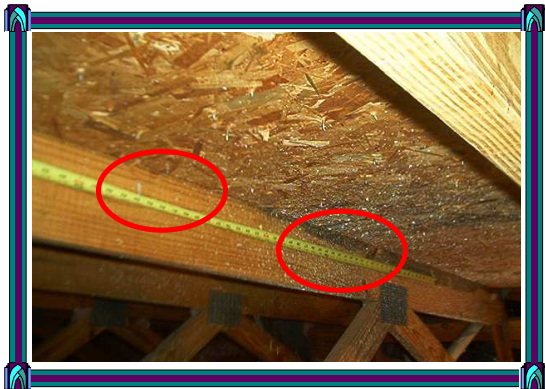
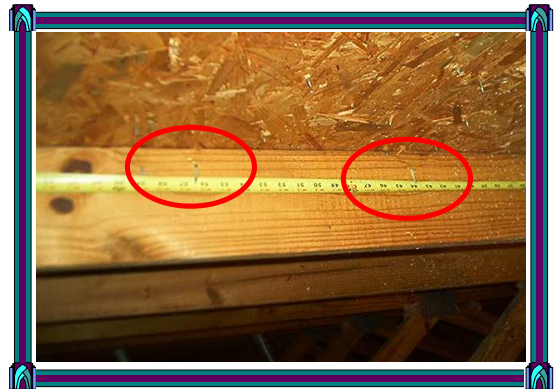
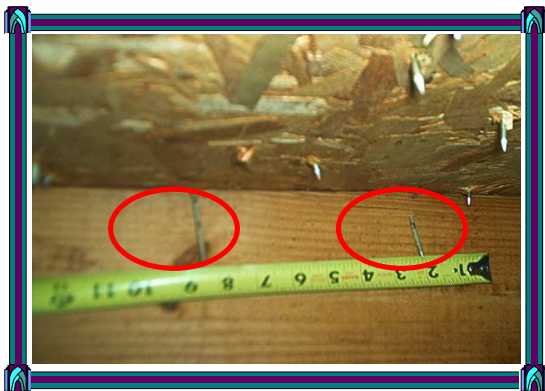
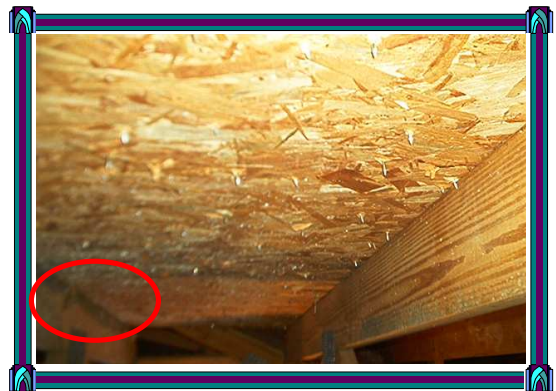
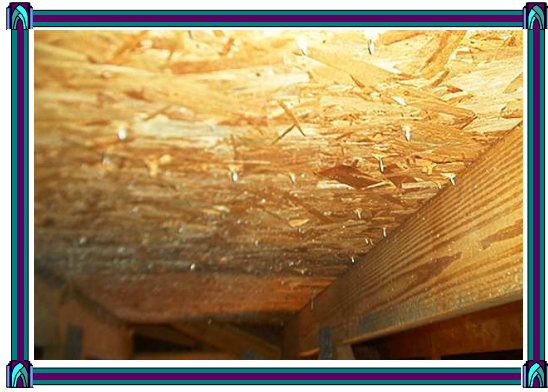
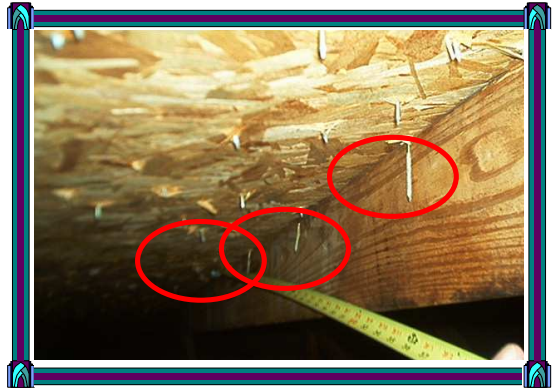
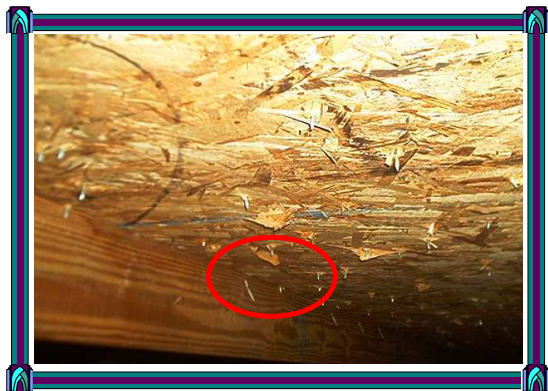
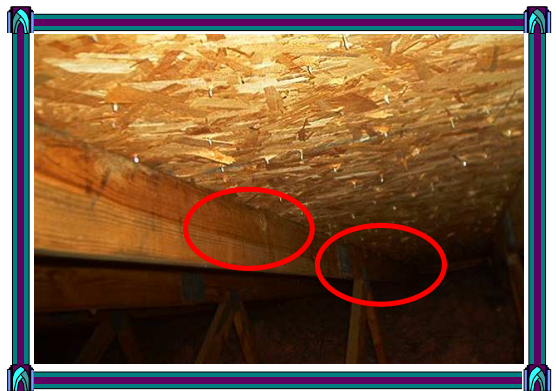
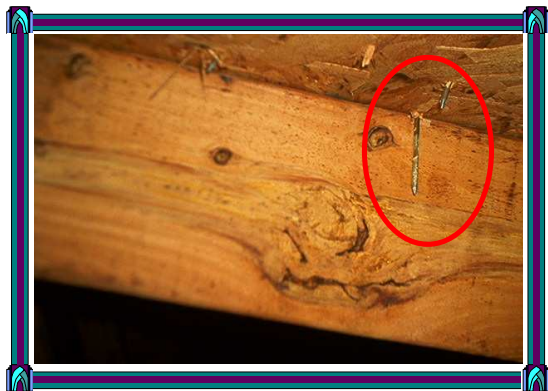
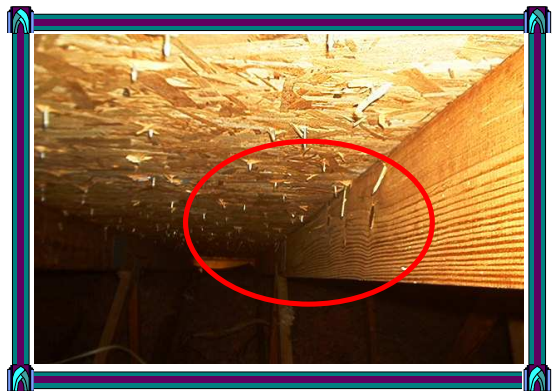
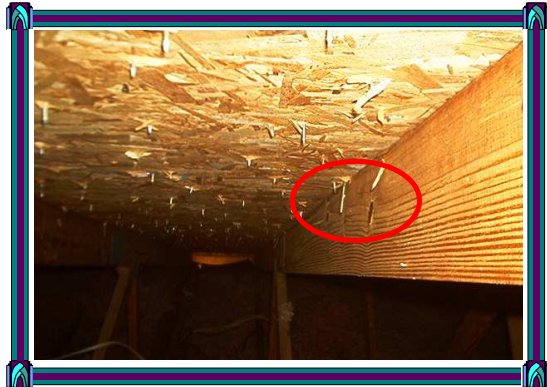
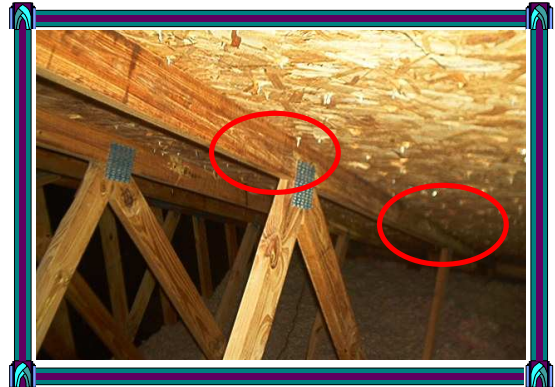
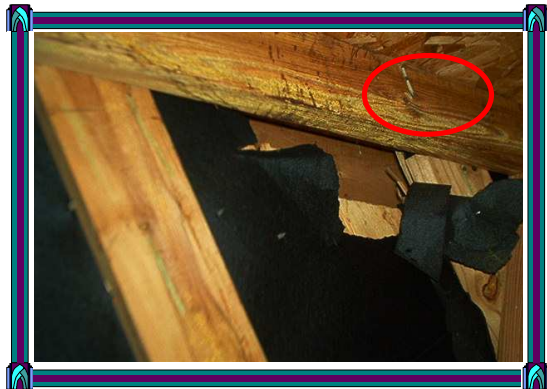
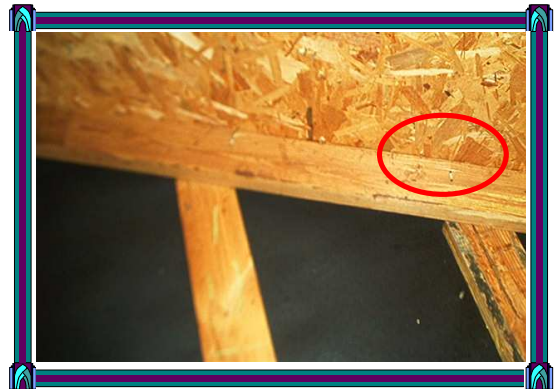
The following three pages of pictures show the numerous missed studs in the attic.

This does not conform to the local building code pertaining to the nailing pattern.
